Annual Inspection

The Jubilee RG (Bramdean and Hinton Ampner PC)

Inspection Ref: 1299819

Inspected: 25-February-2021 - 14:29 by Daryl Cormack

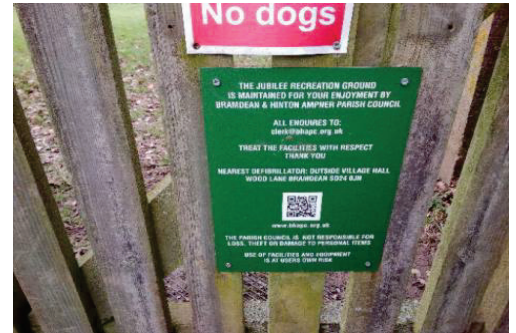
Item: Sign
Manufacturer: Owner/Operator
Surface Type: N/A
Item Quantity: 1
Equipment Compliance: N/A
Surface Area Compliance: N/A

BS EN 1176 Part 7 recommends that signage shall include the site name / address - Provide additional information

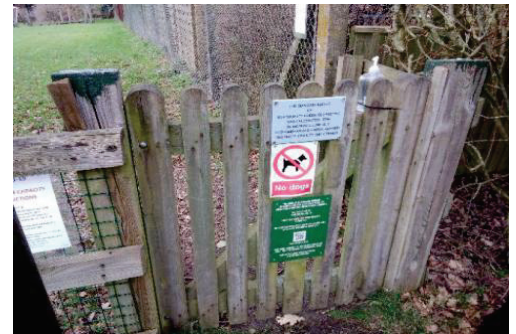
Item: Gate
Manufacturer: Owner/Operator
Surface Type: Grass
Item Quantity: 1
Equipment Compliance: N/A
Surface Area Compliance: N/A

There are openings that are less than 12mm that could trap or crush fingers - Where possible a 12mm gap should be maintained on both sides or between the gate leaves

The gate is not operating correctly - Take effective action to ensure the gate closes between 4 and 8 seconds

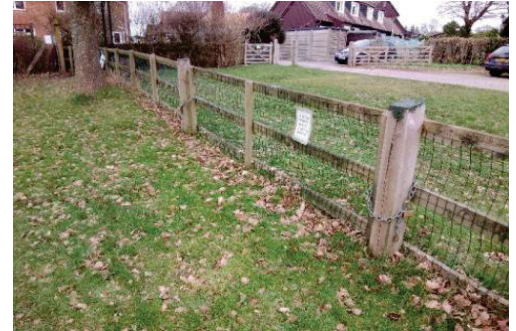
Item: Gate - Maintenance
Manufacturer: Owner/Operator
Surface Type: Grass
Item Quantity: 1
Equipment Compliance: N/A
Surface Area Compliance: N/A

The use of synthetic fillers in timber is not recommended; timber being a natural material will expand and contract as the moisture content changes and the use of fillers can exacerbate the length and depth of these cracks or shakes in the timber. The only treatment that is normally required is the removal of any rough or sharp edges unless the structural integrity of the item is affected. - Remove any rough or sharp edges and monitor timber for any further deterioration

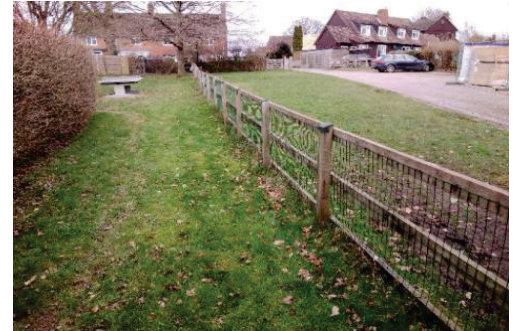
Item: Fence - Timber & Mesh Infill
Manufacturer: Owner/Operator
Surface Type: Grass
Item Quantity: 1
Equipment Compliance: N/A
Surface Area Compliance: N/A

There is some strimmer / machinery damage apparent on the posts, this can penetrate the preservative applied to the timber and accelerate the rotting process - Monitor for any deterioration (rot) and replace as required

There are a number of loose posts around the fence - Monitor for any further deterioration and reset as required

There are areas or parts of the timber posts on the structure that have rotted - Replace all affected timbers

The use of synthetic fillers in timber is not recommended; timber being a natural material will expand and contract as the moisture content changes and the use of fillers can exacerbate the length and depth of these cracks or shakes in the timber. The only treatment that is normally required is the removal of any rough or sharp edges unless the structural integrity of the item is affected. - Remove any rough or sharp edges and monitor timber for any further deterioration

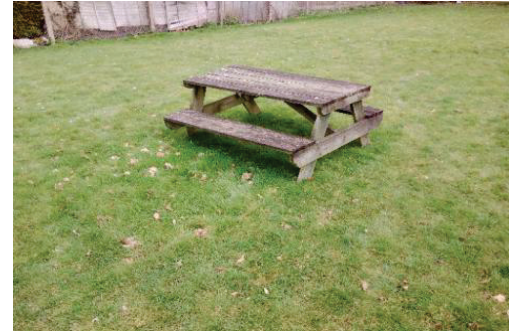
Item: Picnic Table
Manufacturer: Owner/Operator
Surface Type: Grass
Item Quantity: 1
Equipment Compliance: N/A
Surface Area Compliance: N/A

The bench is not securely fixed to the surface and there is some possibility of the item tipping or rolling over - Secure the bench to the ground

There is algae or moss on the surface of the equipment - Clean and treat appropriately

There is some evidence of rot in the timber - Monitor for any further deterioration and replace as required

Parts of the timber are rough or splintered - Remove all rough or sharp edges

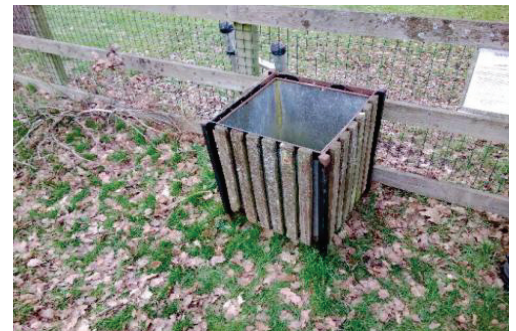
Item: Litter Bin
Manufacturer: Owner/Operator
Surface Type: Grass
Item Quantity: 1
Equipment Compliance: N/A
Surface Area Compliance: N/A

The paintwork on this item has been damaged or worn exposing the metal underneath which is rusting - Treat any rusting components and repaint

The liner of the litter bin is not secured - Ensure the lid/door is kept locked and the liner secured

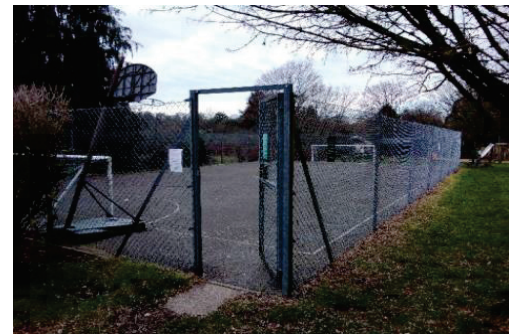
Item: Ball Games Area
Manufacturer: Unknown
Surface Type: Bitmac
Item Quantity: 1
Equipment Compliance: N/A
Surface Area Compliance: N/A

There are a number of loose posts around the fence - Monitor for any further deterioration and reset as required

The goal posts are loose in the foundations - Monitor for any further deterioration and reset as required

There is some damage to the fence sections - Monitor for any further deterioration and repair as required

There is or are fixings missing on the item - Replace all missing fixings

There are freestanding netball posts within the area - Remove

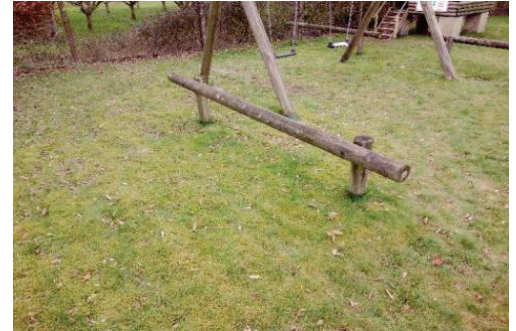
Item: Swing Barrier
Manufacturer: Playdale Playgrounds Ltd
Surface Type: Grass
Item Part Number:
Item Quantity: 6
Equipment Compliance: N/A
Surface Area Compliance: N/A
Total Findings: 2

There is some strimmer / machinery damage apparent on the posts, this can penetrate the preservative applied to the timber and accelerate the rotting process - Monitor for any deterioration (rot) and replace as required

The timber has a number of splits/shakes or air cracks and this may affect the stability or allow water ingress which will accelerate the rotting process - Monitor to ensure the splits do not cross through fixing points of the structure and/or cause any instability

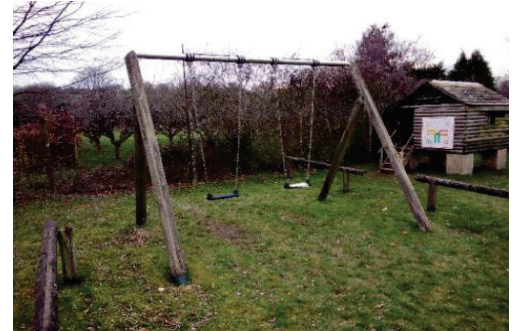
Item: 1 Bay 2 Seat (Flat)
Manufacturer: Playdale Playgrounds Ltd
Surface Type: Grass
Item Quantity: 1
Equipment Compliance: Yes
Surface Area Compliance: Yes

There is some strimmer / machinery damage apparent on the posts, this can penetrate the preservative applied to the timber and accelerate the rotting process - Monitor for any deterioration (rot) and replace as required

Parts of the timber are rough or splintered - Remove all rough or sharp edges

Cable ties present - Remove cable ties

There is some evidence of rot in the timber posts x3 - Monitor for any further deterioration and replace as required

BS EN 1176 Part 2: Annex A makes a recommendation that fences or enclosures should be upto 1.50m from the edges of the swing seat to the sides, and subject to risk assessment, from the edge of the impact area. This is however, a low risk finding and no remedial action is recommended. - Monitor - No remedial work recommended

The seat has minor damage or wear - Monitor for any further deterioration and replace as required

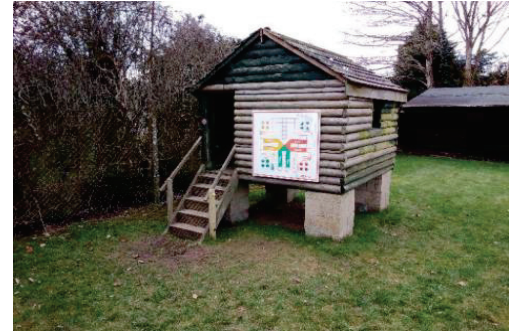
Item: Playhouse
Manufacturer: Unknown
Surface Type: Grass
Item Quantity: 1
Equipment Compliance: No
Surface Area Compliance: No

The item fails to meet the requirements of BS EN 1176 Part 1 4.2.7.2 for head and neck entrapment in the window - Monitor - No remedial work recommended

The chain link fence forms a hard object within the impact area of the equipment in contravention of the requirements of BS EN 1176 Part 1 - Monitor - No remedial work recommended

Parts of the timber are rough or splintered - Remove all rough or sharp edges

There is some evidence of rot in the timber - Monitor for any further deterioration and replace as required

The area around the item has eroded and may become slippery - Reinststate eroded area

There are projecting nail ends present - Remove and provide more appropriate fixings if required

This equipment has not been designed or installed to meet with the requirements of BS EN 1176 for public playground equipment; we have however used our knowledge of these standards to assist in forming the basis of our report. - The equipment should either be removed from use or written confirmation be sought from the supplier concerning the suitability of this equipment for the intended use

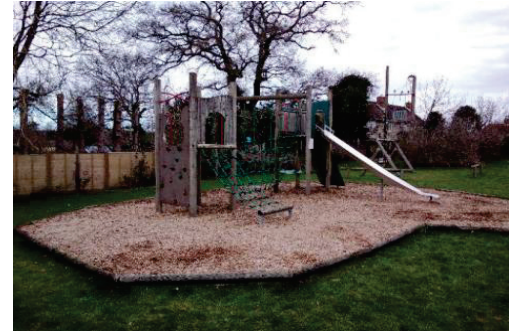
Item: Multi Play (Junior)
Manufacturer: Playdale Playgrounds Ltd
Surface Type: Bark Mulch
Item Quantity: 1
Equipment Compliance: No
Surface Area Compliance: Yes

The net climber base forms a hard object within the impact area of the equipment in contravention of the requirements of BS EN 1176 Part 1 - Monitor - No remedial work recommended

The loose fill safety surfacing has become compacted - Rake and fork over to aerate the surface

There is some evidence of rot in the timber edging - Monitor for any further deterioration and replace as required

Parts of the timber are rough or splintered - Remove all rough or sharp edges

There is/are finger entrapment/s in the between post and platform and the item fails to meet the requirements of BS EN 1176 Part 1 4.2.7.6 Entrapment of fingers - Monitor - No remedial work recommended

There is some evidence of rot in the timber posts - Monitor for any further deterioration and replace as required

There is some evidence of rot in the timber panels - Monitor for any further deterioration and replace as required

There is some evidence of rot in the timber framework - Monitor for any further deterioration and replace as required

A number of fixing(s) have worked loose - Secure all loose fixings

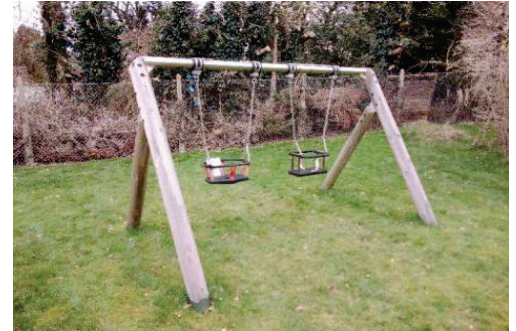
Item: 1 Bay 2 Seat (Cradle)
Manufacturer: Playdale Playgrounds Ltd
Surface Type: Grass
Item Quantity: 1
Equipment Compliance: Yes
Surface Area Compliance: Yes

The seat has minor damage or wear - Monitor for any further deterioration and replace as required

Cable ties on suspension member - Remove cable ties

There is some notable evidence of chain wear - Monitor for any further deterioration and replace when 40% worn

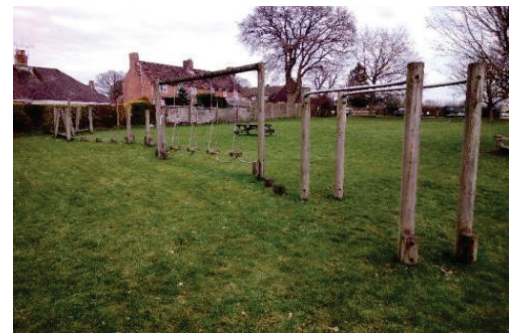
Item: Activity Trail
Manufacturer: Playdale Playgrounds Ltd
Surface Type: Grass Matrix Tiles
Item Quantity: 1
Equipment Compliance: Yes
Surface Area Compliance: Yes

The timber on this item has severe rot in stepping post - Remove and replace all affected timber sections

There is algae or moss on the surface of the equipment - Clean and treat appropriately

There is some evidence of rot in the timber posts - Monitor for any further deterioration and replace as required

There are areas or parts of the timber stepping post that have rotted - Replace all affected timbers

There is some strimmer / machinery damage apparent on the posts, this can penetrate the preservative applied to the timber and accelerate the rotting process - Monitor for any deterioration (rot) and replace as required

There is some wear to the shackles - Monitor for any further deterioration and replace when 40% worn

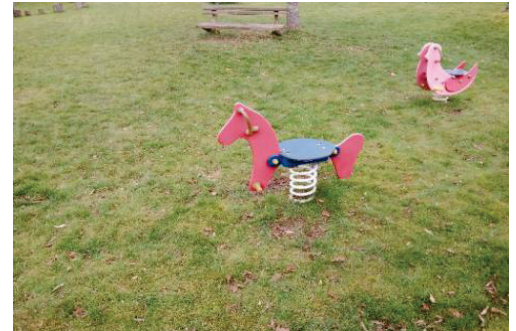
Item: Spring Horse
Manufacturer: Ledon
Surface Type: Grass
Item Quantity: 1
Equipment Compliance: No
Surface Area Compliance: Yes

The area around the item has eroded and may become slippery - Reinstate eroded area

The end of handgrips and/or footrests have a cross section of less than 15cm² and fail to meet the requirements of BS EN 1176 Part 6 - Monitor - No remedial work recommended

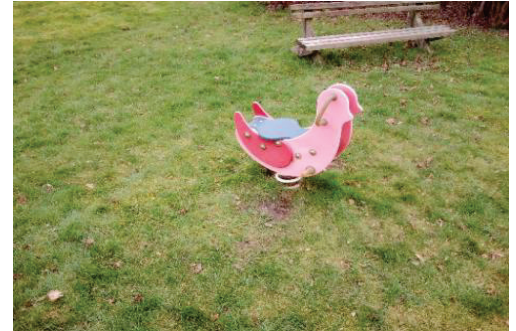
Item: Spring Chicken
Manufacturer: Ledon
Surface Type: Grass
Item Quantity: 1
Equipment Compliance: No
Surface Area Compliance: Yes

The end of handgrips and/or footrests have a cross section of less than 15cm² and fail to meet the requirements of BS EN 1176 Part 6 - Monitor - No remedial work recommended

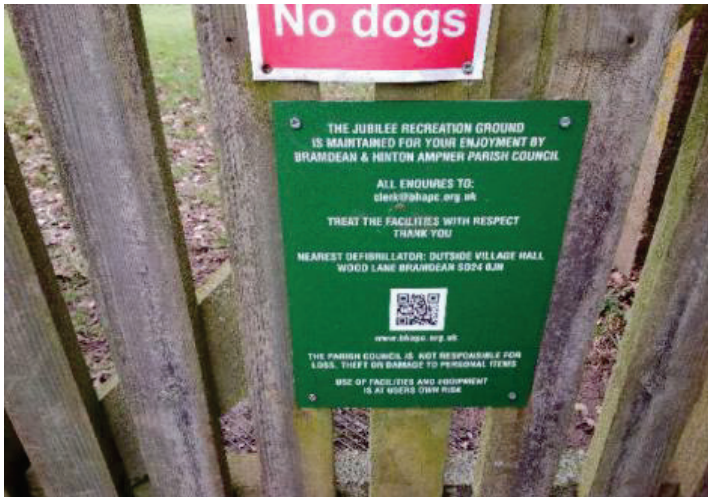
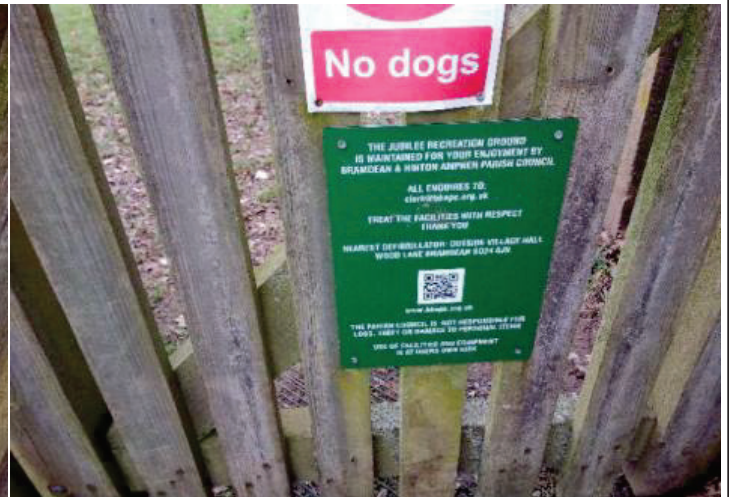
Item: Ancillary Items - Sign
Manufacturer: Owner/Operator

Finding: BS EN 1176 Part 7 recommends that signage shall include the site name / address
Action: Provide additional information

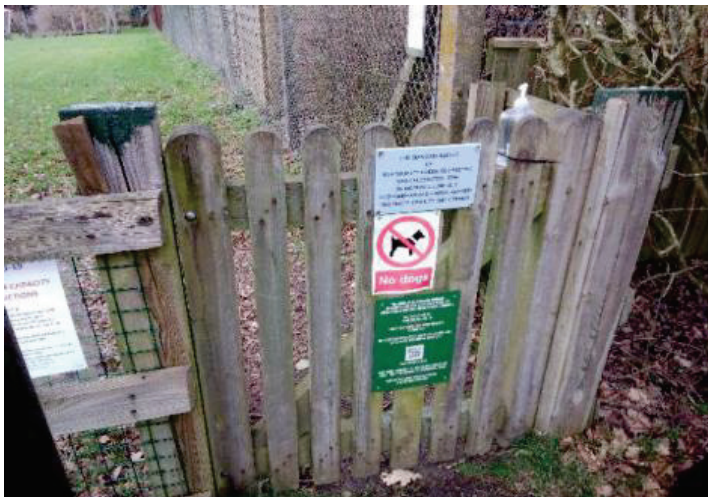
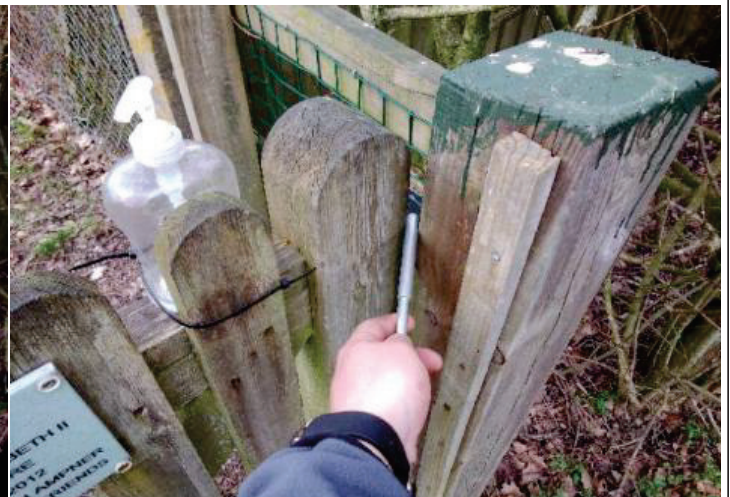
Item: Gates - Gate
Manufacturer: Owner/Operator

Finding: There are openings that are less than 12mm that could trap or crush fingers

Action: Where possible a 12mm gap should be maintained on both sides or between the gate leaves

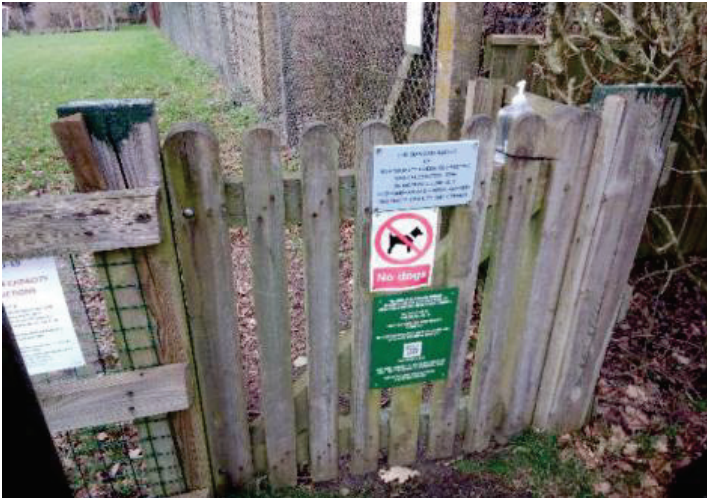
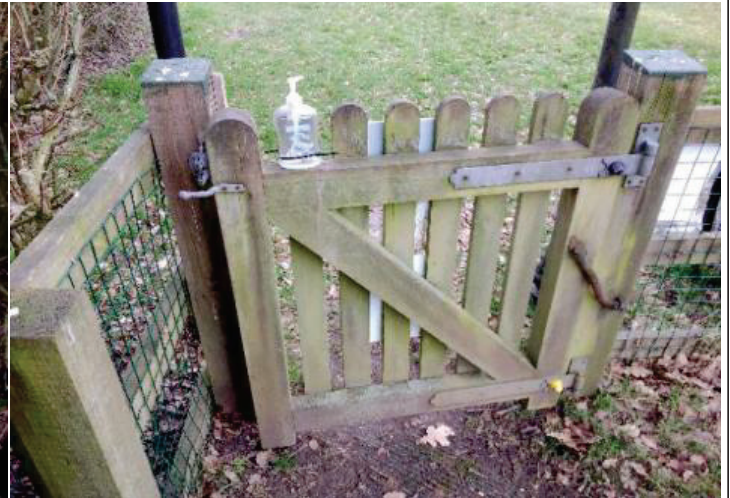
Item: Gates - Gate
Manufacturer: Owner/Operator

Finding: The gate is not operating correctly

Action: Take effective action to ensure the gate closes between 4 and 8 seconds

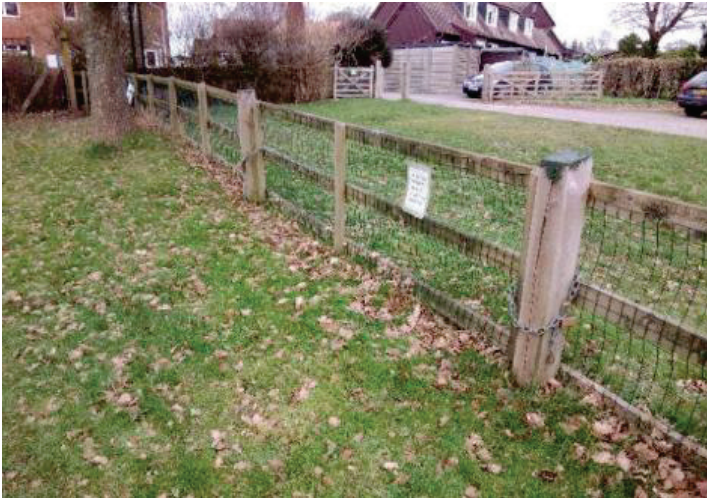
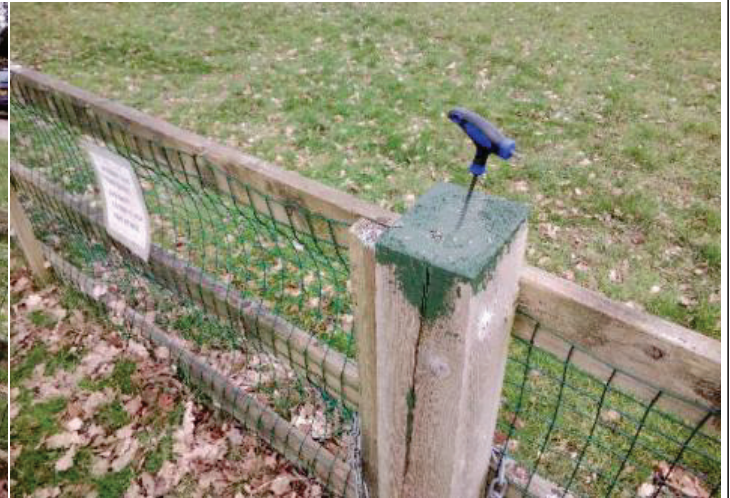
Item: Gates - Gate - Maintenance
Manufacturer: Owner/Operator

Finding: The use of synthetic fillers in timber is not recommended; timber being a natural material will expand and contract as the moisture content changes and the use of fillers can exacerbate the length and depth of these cracks or shakes in the timber. The only treatment that is normally required is the removal of any rough or sharp edges unless the structural integrity of the item is affected.

Action: Remove any rough or sharp edges and monitor timber for any further deterioration
