the **play inspection** company

Annual Inspection

The Jubilee RG (Bramdean and Hinton Ampner PC)

Inspection Ref: 1999059

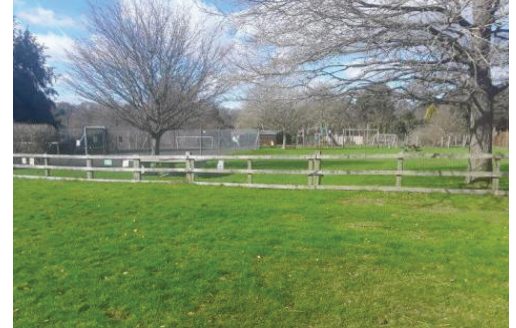
Item: Site General
Manufacturer: Owner/Operator
Surface Type: N/A
Item Quantity: 1
Equipment Compliance: N/A
Surface Area Compliance: N/A

We do not recommend the use of bird spikes - Remove and replace with upturned cable ties

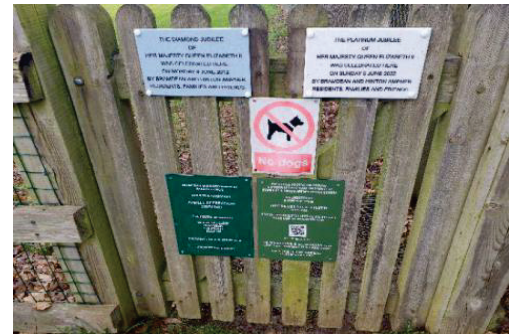
Item: Sign
Manufacturer: Owner/Operator
Surface Type: N/A
Item Quantity: 1
Equipment Compliance: N/A
Surface Area Compliance: N/A

BS EN 1176 Part 7 recommends that signage shall include emergency contact details and contact details of owner / operator for reporting maintenance issues - Provide additional information

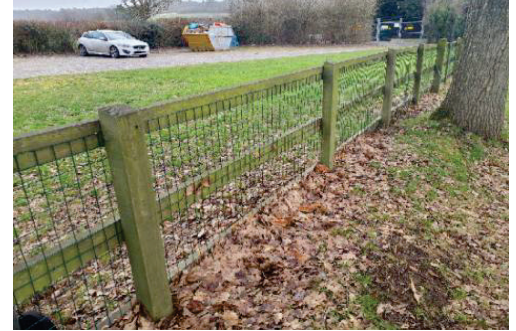
Item: Fence - Timber & Mesh Infill
Manufacturer: Not Identified
Surface Type: Grass
Item Quantity: 1
Equipment Compliance: N/A
Surface Area Compliance: N/A

There are a number of loose posts around the fence - Monitor for any further deterioration and reset as required

There is some evidence of rot in the timber - Monitor for any further deterioration and replace as required

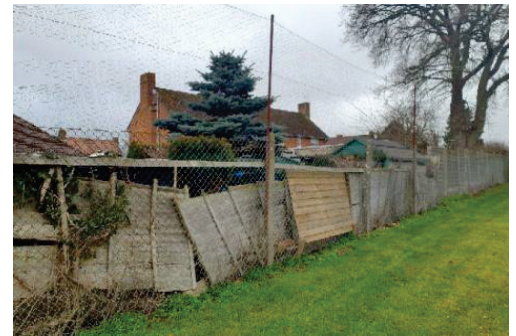
Item: Fence - Chainlink
Manufacturer: Not Identified
Surface Type: Grass
Item Quantity: 1
Equipment Compliance: N/A
Surface Area Compliance: N/A

The fence is severely damaged in places - Repair or replace all affected sections

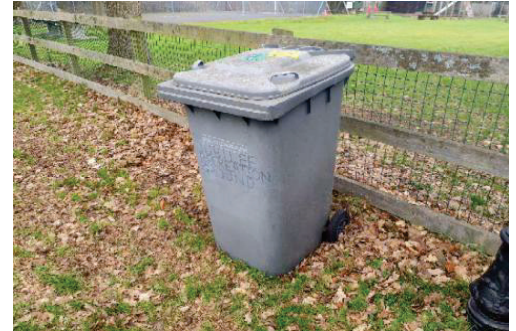
Item: Litter Bin
Manufacturer: Not Identified
Surface Type: Grass
Item Quantity: 1
Equipment Compliance: N/A
Surface Area Compliance: N/A

The bin is not securely fixed to the surface and there is some possibility of the item tipping or rolling over - Secure the bin to the ground

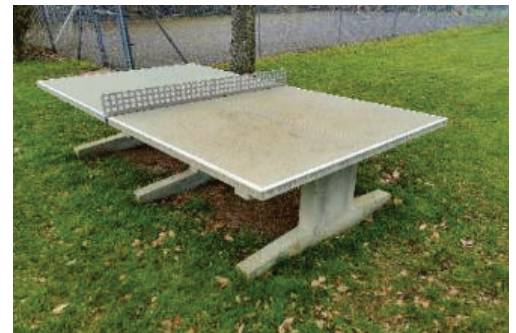
Item: Table Tennis
Manufacturer: Not Identified
Surface Type: Grass
Item Quantity: 1
Equipment Compliance: N/A
Surface Area Compliance: N/A

This item is satisfactory - no work required -

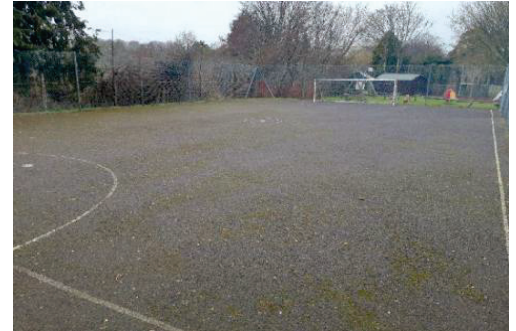
Item: Ball Games Area
Manufacturer: Not Identified
Surface Type: Bitmac
Item Quantity: 1
Equipment Compliance: No
Surface Area Compliance: N/A
Life Expectancy: >10 Years
Total Findings: 9

BS EN 15312 states that gaps whose dimensions change during use shall have a minimum dimension of 18mm - Ensure crushing hazards are removed

The fence is severely damaged in places - Repair or replace all affected sections

The item is slightly loose in its foundations - Monitor for any further deterioration and repair as required

The paintwork on this item has been damaged or worn exposing the metal underneath which is rusting - Treat any rusting components and repaint

A number of fixing(s) have worked loose - Secure all loose fixings

There is or are fixings missing on the item - Replace all missing fixings

There is algae, silt or moss growth on the surface resulting in slippery conditions - Clean and treat appropriately

There are a number of loose posts around the fence - Monitor for any further deterioration and reset as required

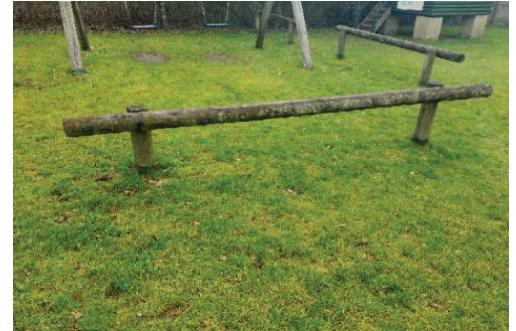
Item: Swing Barrier
Manufacturer: Playdale Playgrounds Ltd
Surface Type: Grass
Item Part Number:
Item Quantity: 6
Equipment Compliance: N/A
Surface Area Compliance: N/A
Total Findings: 3

There is algae or moss on the surface of the equipment -
Clean and treat appropriately

There is some evidence of rot in the timber - Monitor for any
further deterioration and replace as required

There are areas or parts of the timber on the structure that
have rotted - Replace all affected timbers

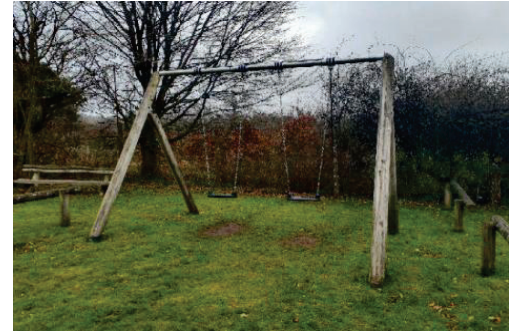
Item: 1 Bay 2 Seat (Flat)
Manufacturer: Playdale Playgrounds Ltd
Surface Type: Grass
Item Quantity: 1
Equipment Compliance: Yes
Surface Area Compliance: Yes
Life Expectancy: 3 - 5 Years
Total Findings: 8

Finding 1
 There is some strimmer / machinery damage apparent on the posts, this can penetrate the preservative applied to the timber and accelerate the rotting process - Monitor for any deterioration (rot) and replace as required

Finding 2
 There is some evidence of rot in the timber - Monitor for any further deterioration and replace as required

Finding 3
 The timber has a number of splits/shakes or air cracks and this may affect the stability or allow water ingress which will accelerate the rotting process - Monitor to ensure the splits do not cross through fixing points of the structure and/or cause any instability

Finding 4
 There are areas or parts of the timber on the structure that have rotted - Replace all affected timbers

Finding 5
 There are areas or parts of the timber on the structure that have rotted - Replace all affected timbers

Finding 7
 There is some notable evidence of chain wear - Monitor for any further deterioration and replace when 40% worn

Finding 8
 The seat has minor damage or wear - Monitor for any further deterioration and replace as required

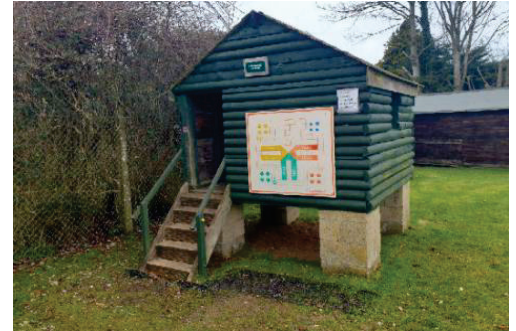
Item: Playhouse
Manufacturer: Not Identified
Surface Type: Grass
Item Quantity: 1
Equipment Compliance: N/A
Surface Area Compliance: N/A
Life Expectancy: 5 -10 Years
Total Findings: 6

The edges of the grass mat surface have not been installed in accordance with the API Code of Practice - Tuck in edges of grass mat to remove trip hazards

The fence forms a hard object within the falling space of the equipment and there is also insufficient surfacing provided in contravention of BS EN 1176 Part 1 - Monitor - no remedial work recommended

The item has exposed edges and corners with a radius of less than 3mm and fails the requirements of BS EN 1176 - Provide a 3mm radius to all exposed edges and corners

The item fails to meet the requirements of BS EN 1176 Part 1 4.2.7.2 for head and neck entrapment in the window - Monitor - No remedial work recommended

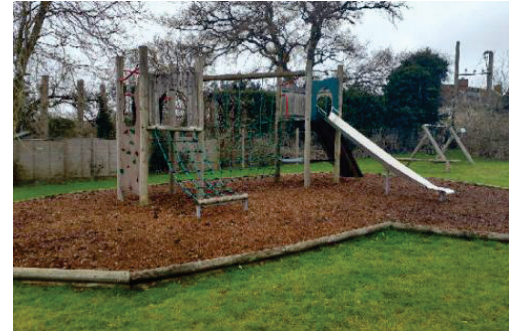
Item: Multi Play (Junior)
Manufacturer: Playdale Playgrounds Ltd
Surface Type: Bark Mulch
Item Quantity: 1
Equipment Compliance: No
Surface Area Compliance: Yes
Life Expectancy: 5 -10 Years
Total Findings: 23

The loose fill safety surfacing has become compacted - Rake and fork over to aerate the surface

There are falls in excess of 600mm between adjacent components on the structure, in contravention of the recommendations set out in BS EN 1176 Part 1; 4.2.8.4 - Monitor - No remedial work recommended

There is some evidence of rot in the timber - Monitor for any further deterioration and replace as required

There are areas or parts of the timber on the structure that have rotted - Replace all affected timbers

The surface has eroded and the foundations are exposed - Reinstate surrounding surfaces to cover the foundations

The depth of the loose fill surfacing is lower than the recommended depth specified in BS EN 1176; the free height of fall of the equipment is less than 2.0m and a minimum of 300mm depth should be provided (including an extra 100mm to allow for compaction and displacement as per BS EN 1176 Part 1 - Table 4) - Top up loose fill surfacing to recommended levels

There is/are finger entrapment/s in the climbing wall and the item fails to meet the requirements of BS EN 1176 Part 1 4.2.7.6 Entrapment of fingers - Monitor - No remedial work recommended

The use of synthetic fillers in timber is not recommended; timber being a natural material will expand and contract as the moisture content changes and the use of fillers can exacerbate the length and depth of these cracks or shakes in the timber. The only treatment that is normally required is the removal of any rough or sharp edges unless the structural integrity of the item is affected. - Remove any rough or sharp edges and monitor timber for any further deterioration

There is some damage to the item - Monitor for any further deterioration and repair as required

The fixings have corroded excessively - Replace all corroded fixings

There is some evidence of rot in the timber barrier slats - Monitor for any further deterioration and replace as required

There is/are bolt cap covers missing or damaged on the item - Replace missing or damaged bolt cap covers

There is some evidence of rot in the timber edging - Monitor for any further deterioration and replace as required

There is/are finger entrapment/s in the beam and the item fails to meet the requirements of BS EN 1176 Part 1 4.2.7.6 Entrapment of fingers - Monitor - No remedial work recommended

The connecting links are in excess of 8.6mm and less than 12mm and fail the requirements of BS EN 1176 Part 1; clause 4.2.13, Chains - Monitor - No remedial work recommended

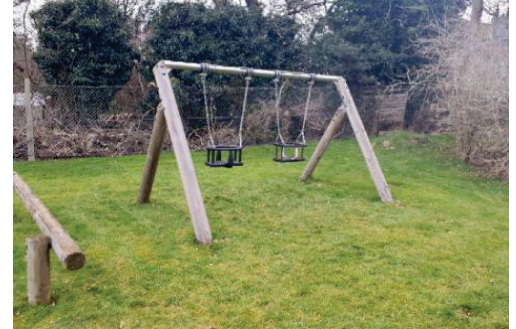
Item: 1 Bay 2 Seat (Cradle)
Manufacturer: Playdale Playgrounds Ltd
Surface Type: Grass
Item Quantity: 1
Equipment Compliance: Yes
Surface Area Compliance: Yes
Life Expectancy: 3 - 5 Years
Total Findings: 4

There is some strimmer / machinery damage apparent on the posts, this can penetrate the preservative applied to the timber and accelerate the rotting process - Monitor for any deterioration (rot) and replace as required

There is some evidence of rot in the timber - Monitor for any further deterioration and replace as required

The seat has minor damage or wear - Monitor for any further deterioration and replace as required

There is some notable evidence of chain wear - Monitor for any further deterioration and replace when 40% worn

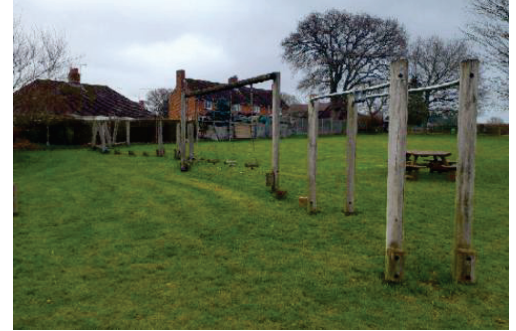
Item: Activity Trail
Manufacturer: Playdale Playgrounds Ltd
Surface Type: Grass Matrix Tiles
Item Quantity: 1
Equipment Compliance: Yes
Surface Area Compliance: Yes
Life Expectancy: 3 - 5 Years
Total Findings: 7

There is some strimmer / machinery damage apparent on the posts, this can penetrate the preservative applied to the timber and accelerate the rotting process - Monitor for any deterioration (rot) and replace as required

There is some notable evidence of chain wear - Monitor for any further deterioration and replace when 40% worn

The inspector has some concerns about the internal condition of the timber and was unable to verify the structural integrity without further testing. We recommend a Resi-PD survey to establish the condition of the timber at it's core. - Contact the Play Inspection Company office for further information

The timber on this item has severe rot (the timber fell apart very easily - the inspector relocated the timber pieces to a bush) - Replace all affected timber sections

The item has missing component(s) - Consider replacing missing components

The step between the items is quite large and users may not be able to complete the step without touching ground, the items could therefore be considered to be within the falling space of each other, however the intention of the play activity continuity is easily apparent and foreseeable to the user - Monitor - No remedial work recommended

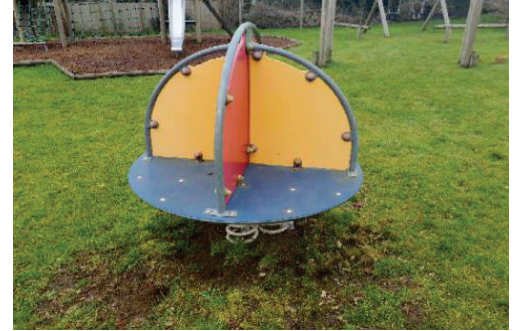
Item: Spring Ark
Manufacturer: Playdale Playgrounds Ltd
Surface Type: Grass Matrix Tiles
Item Quantity: 1
Equipment Compliance: Yes
Surface Area Compliance: Yes
Life Expectancy: 5 -10 Years
Total Findings: 1

There is surface corrosion present on the item - Consider treating the item

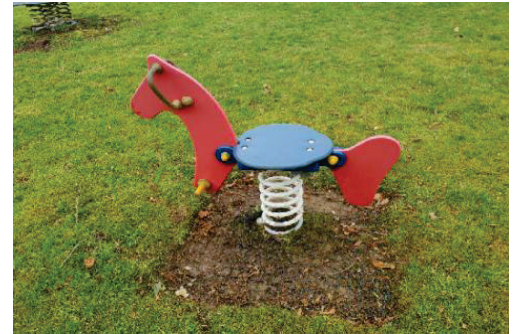
Item: Spring Horse
Manufacturer: Ledon
Surface Type: Grass Matrix Tiles
Item Quantity: 1
Equipment Compliance: No
Surface Area Compliance: Yes
Life Expectancy: 5 -10 Years
Total Findings: 3

The paintwork on the spring has been damaged or worn exposing the metal underneath which is rusting - Treat any rusting components and repaint

The grass mats are silted up and the soil is compacted; this may have an effect on the impact absorbing properties of the surface - Consider HIC testing impact absorbing properties to ensure the correct surface qualities are maintained for the equipment and replace as required

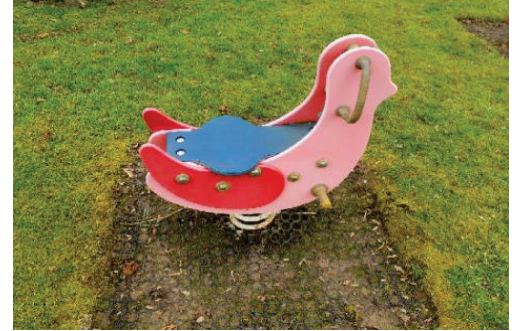
Item: Spring Chicken
Manufacturer: Ledon
Surface Type: Grass
Item Quantity: 1
Equipment Compliance: No
Surface Area Compliance: Yes
Life Expectancy: 5 -10 Years
Total Findings: 4

The end of handgrips and/or footrests have a cross section of less than 15cm² and fail to meet the requirements of BS EN 1176 Part 6 - Monitor - No remedial work recommended

The grass mats are silted up and the soil is compacted; this may have an effect on the impact absorbing properties of the surface - Consider HIC testing impact absorbing properties to ensure the correct surface qualities are maintained for the equipment and replace as required

The paintwork on the spring has been damaged or worn exposing the metal underneath which is rusting - Treat any rusting components and repaint

The spring clamps are loose - Tighten all loose fixings
