## Annual Inspection

Winchester City Council

The Jubilee RG (Bramdean and Hinton Ampner PC)

Off Woodlane Close, Bramdean, Winchester,  
Hampshire, SO24 0JR

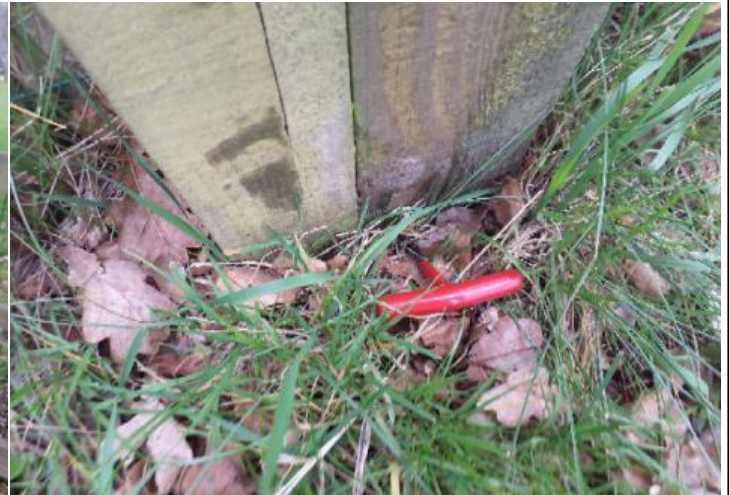
**Finding:** There are areas or parts of the timber on the structure that have rotted

**Action:** Replace all affected timbers

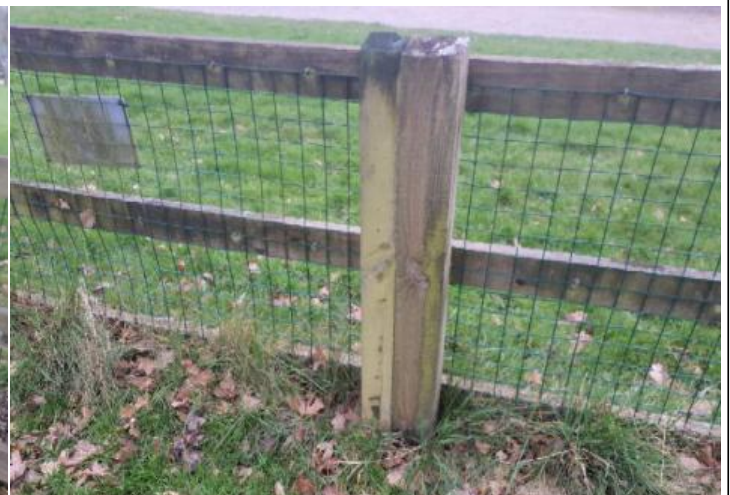
**Finding:** There are a number of loose posts around the fence

**Action:** Monitor for any further deterioration and reset as required

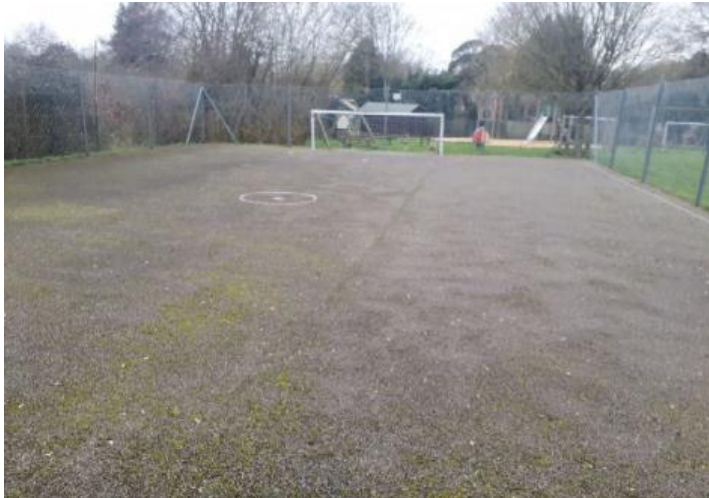
**Finding:** A clearly visible facility sign should be provided in a prominent position with the wording as detailed BS EN 15312- the equipment is not intended for children less than 3 years old- the warning - Do not climb on the framework or nets- the warning - Do not hang on the ring (if provided)- the warning - Do not wear rings or other jewellery- name and telephone number of the administrator- number to call in case of accident

**Action:** Provide signage to BS EN 15312

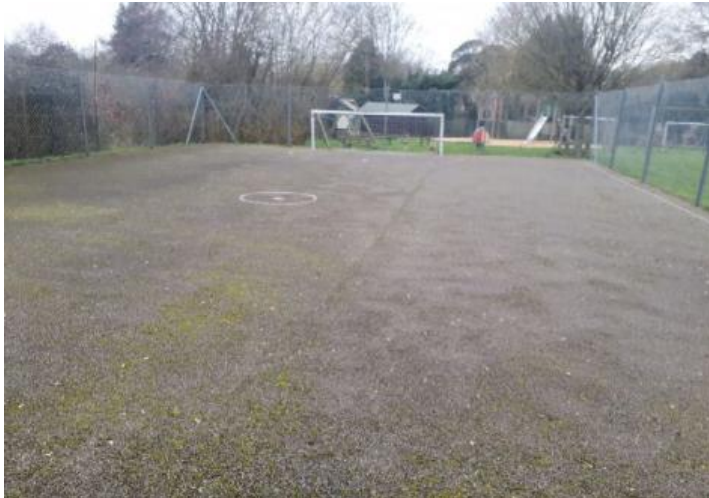
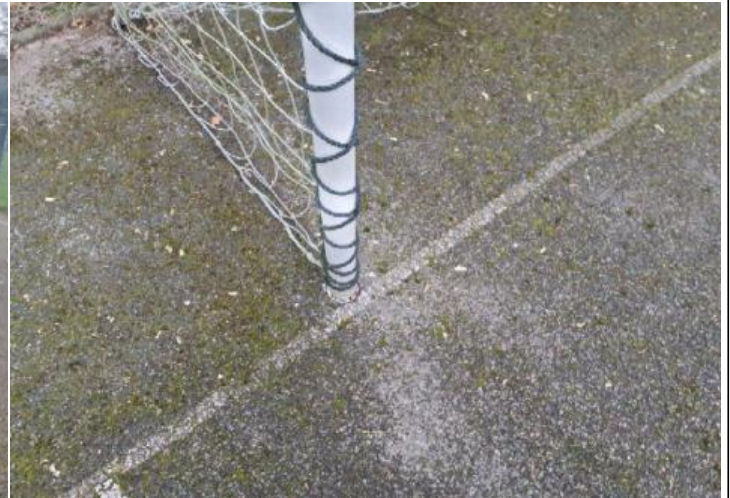
**Finding:** The item is slightly loose in its foundations

**Action:** Monitor for any further deterioration and repair as required

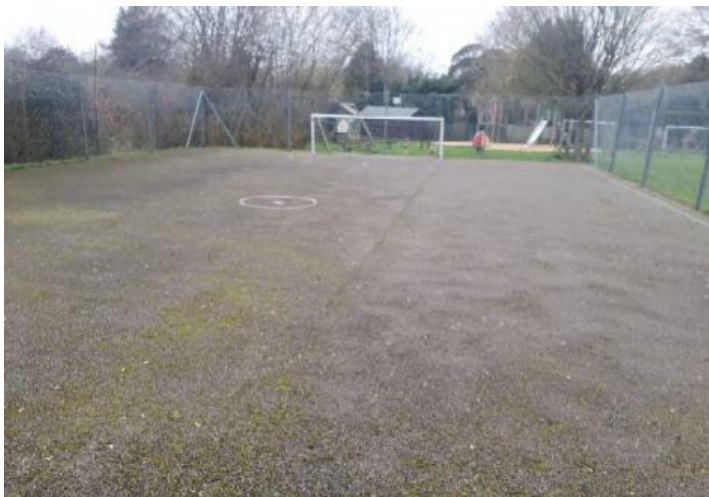
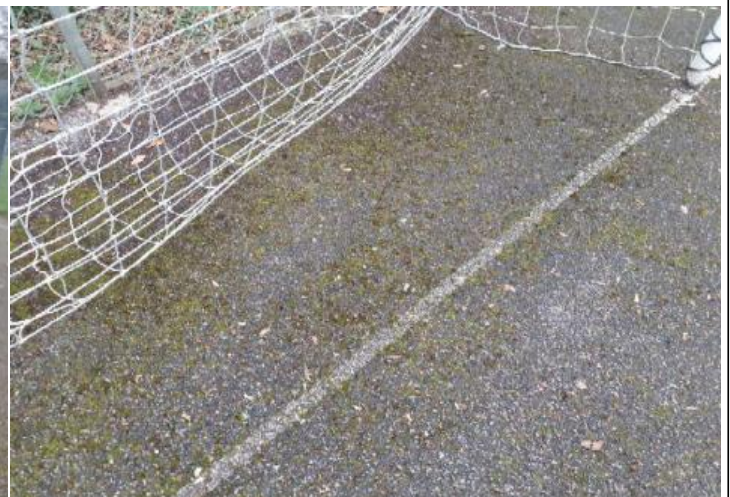
**Finding:** There is algae, silt or moss growth on the surface resulting in slippery conditions

**Action:** Clean and treat appropriately

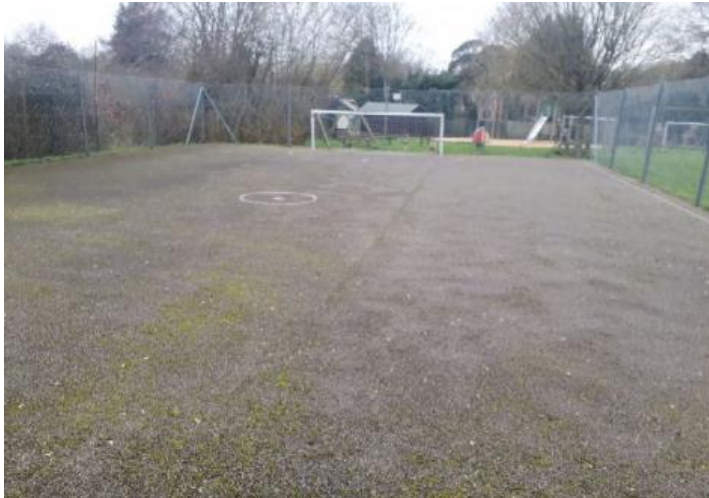
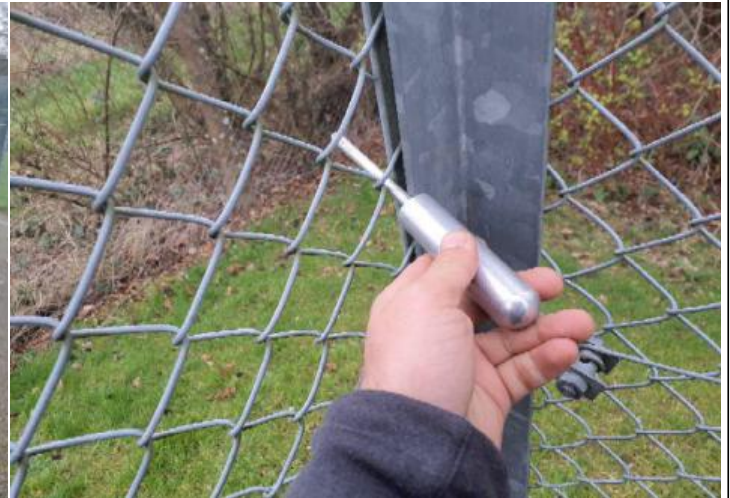
**Finding:** There is/are finger entrapments in the fence and the item fails to meet the requirements of BS EN 15312 Clause 4.4.2.2 Entrapment of fingers    **Action:** Monitor - No remedial work recommended

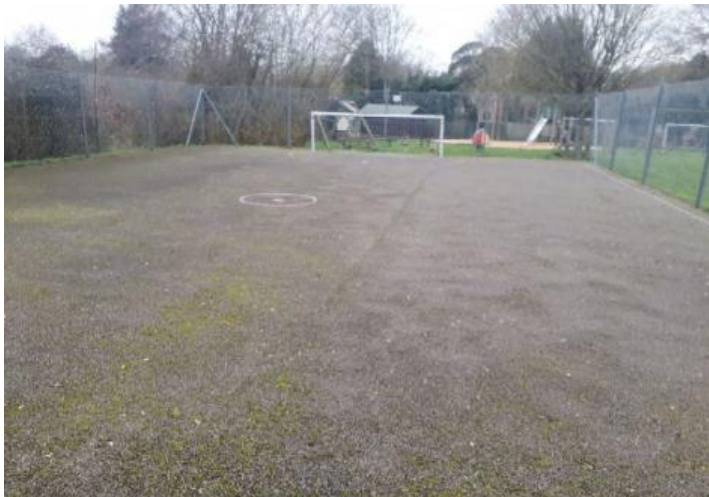
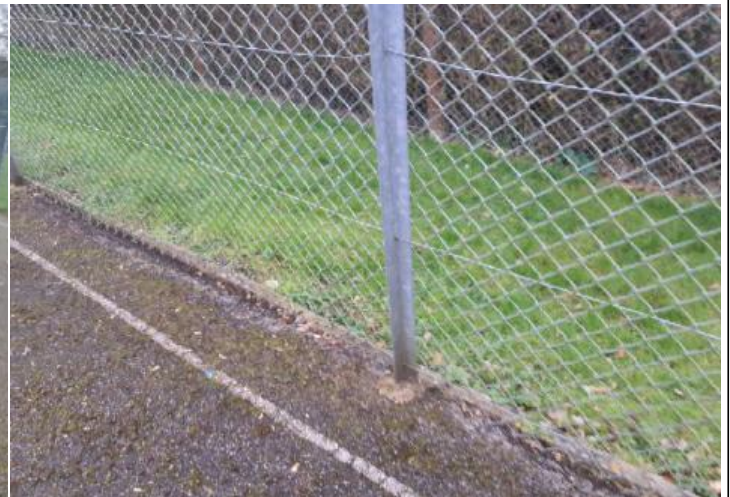
**Finding:** There are a number of loose posts around the fence    **Action:** Monitor for any further deterioration and reset as required

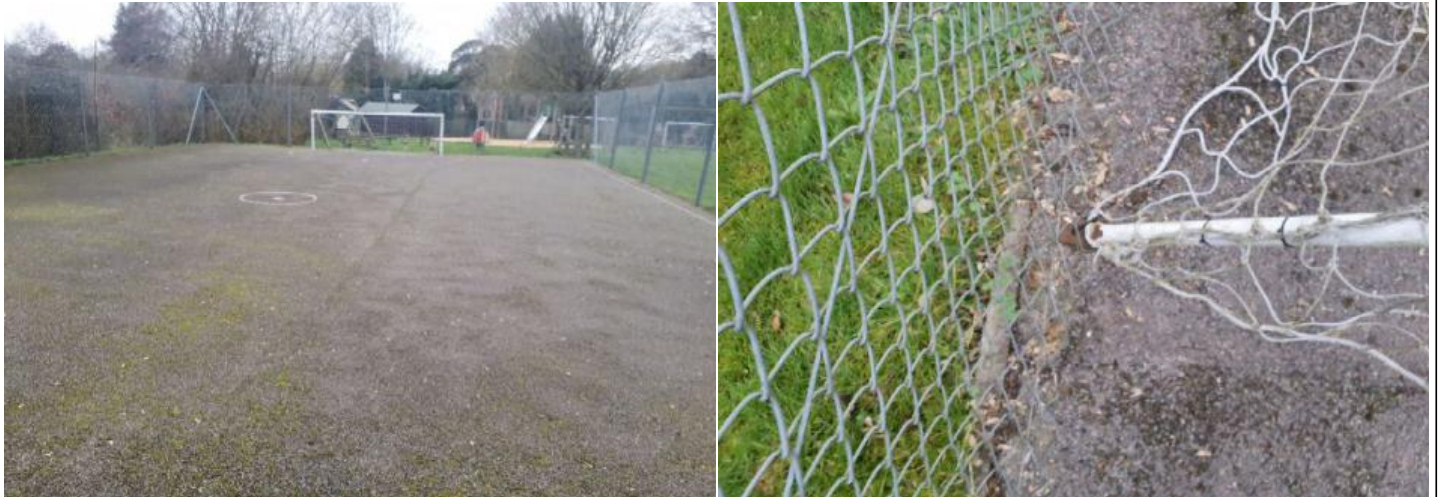
**Finding:** There is or are fixings missing on the item **Action:** Replace all missing fixings

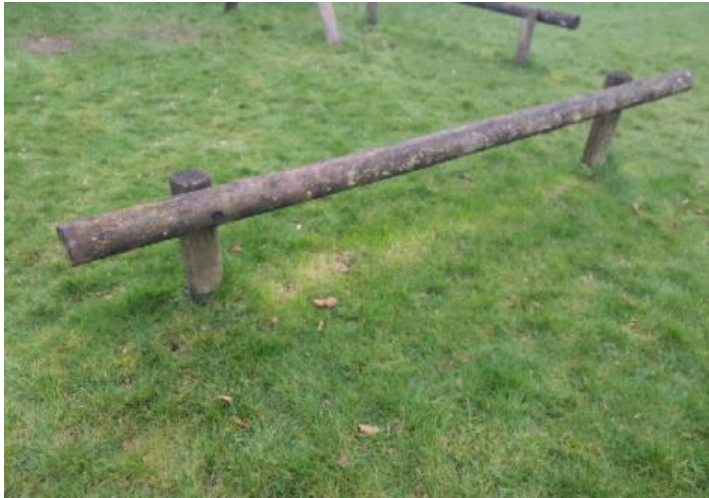
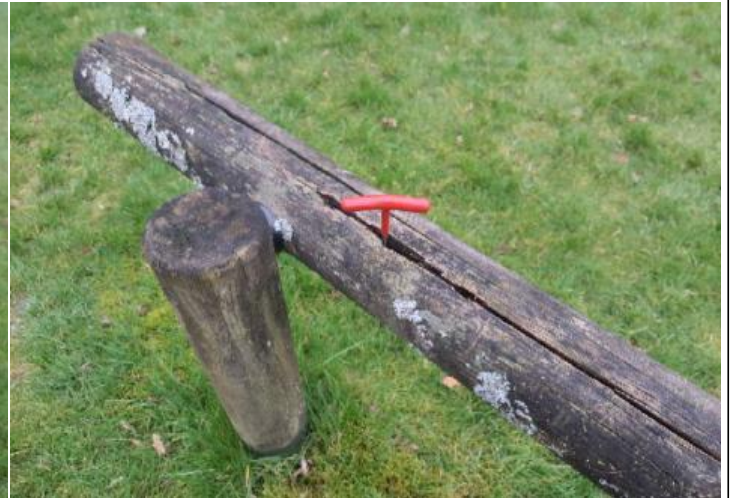
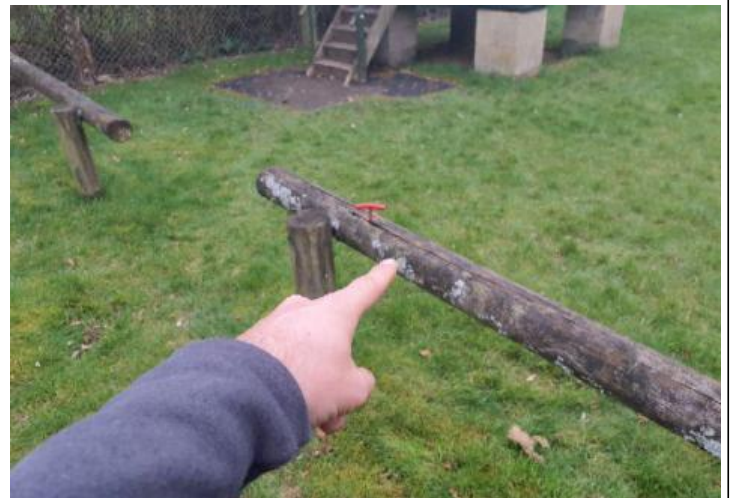
**Finding:** There are areas or parts of the timber on the structure that have rotted

**Action:** Replace all affected timbers

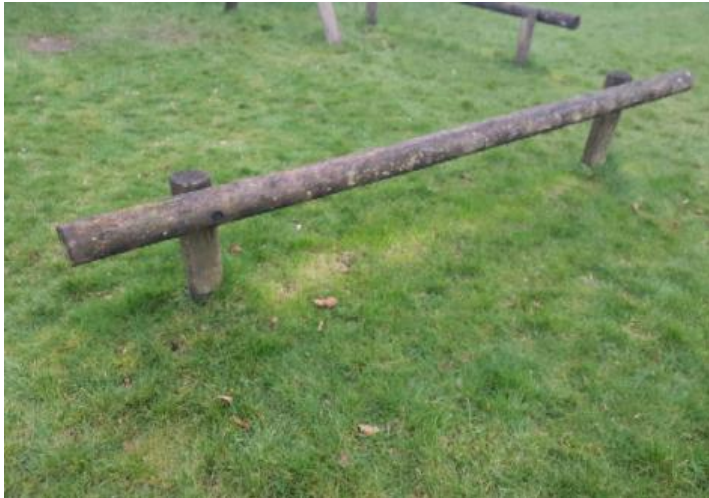
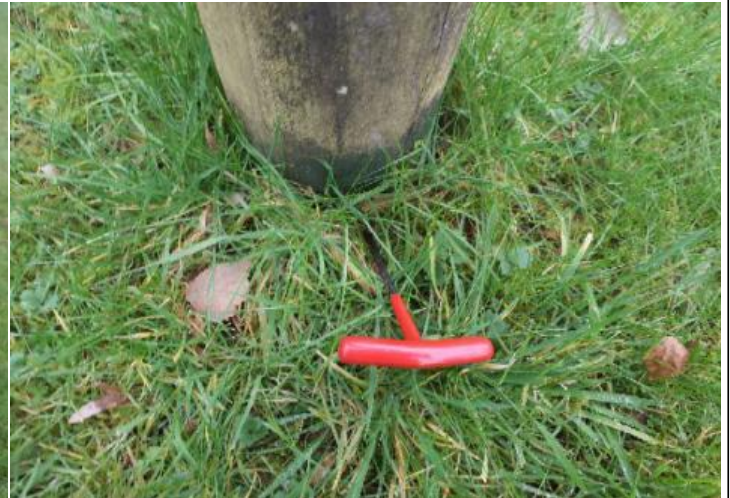
**Finding:** There is some evidence of rot in the timber

**Action:** Monitor for any further deterioration and replace as required

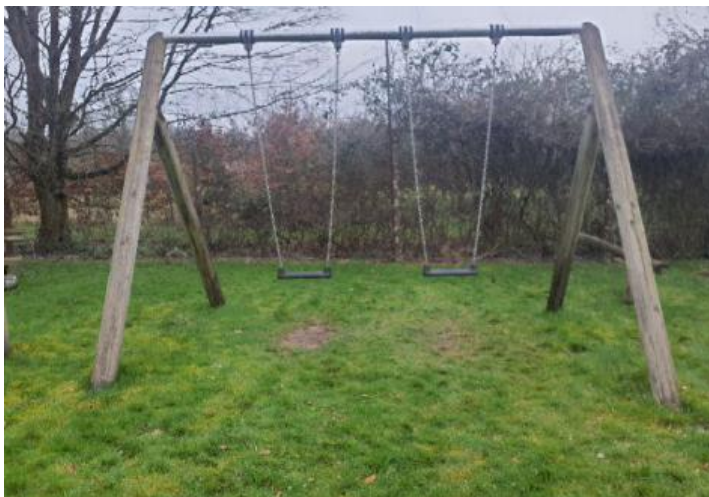
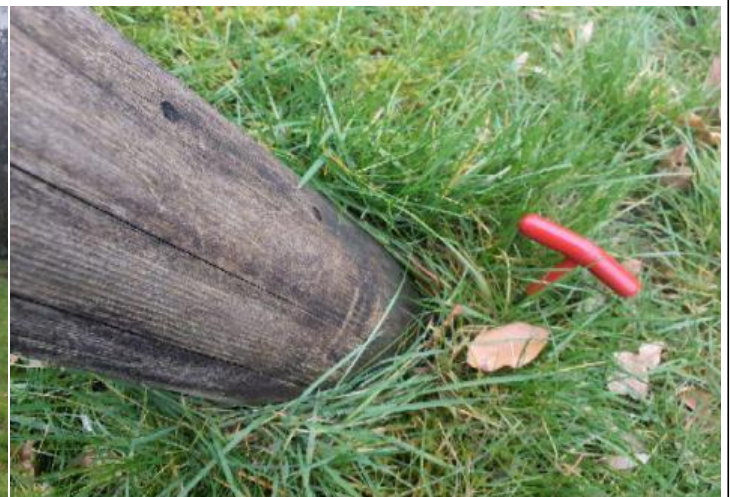
**Finding:** There is some evidence of rot in the timber

**Action:** Monitor for any further deterioration and replace as required

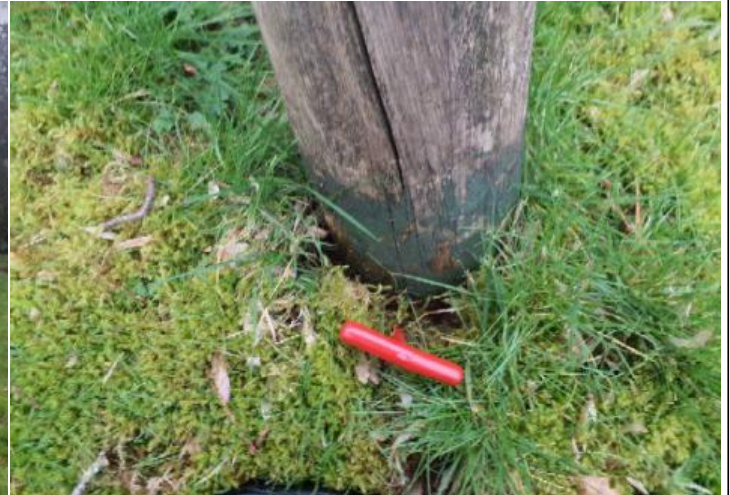
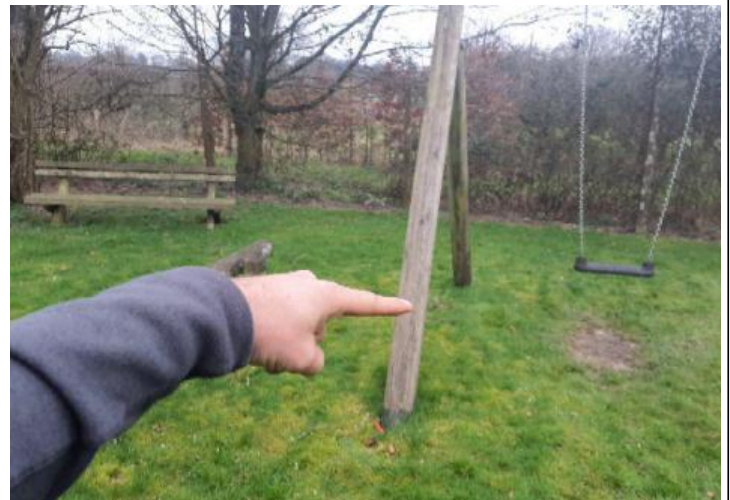
**Finding:** There are areas or parts of the timber on the structure that have rotted

**Action:** Replace all affected timbers

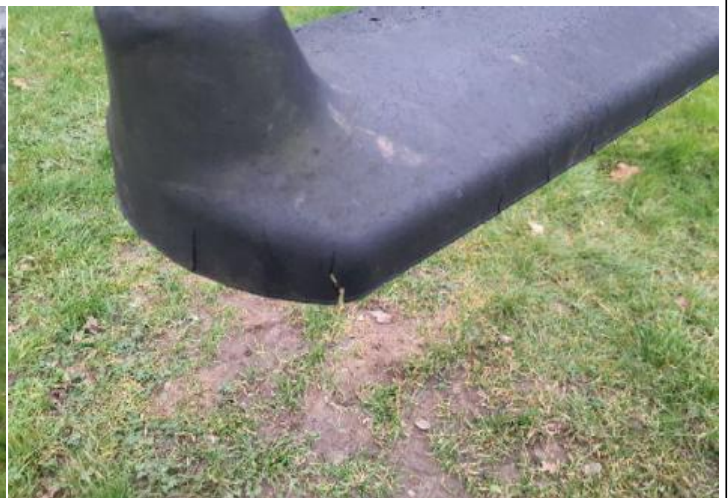
**Finding:** The seat has minor damage or wear

**Action:** Monitor for any further deterioration and replace as required

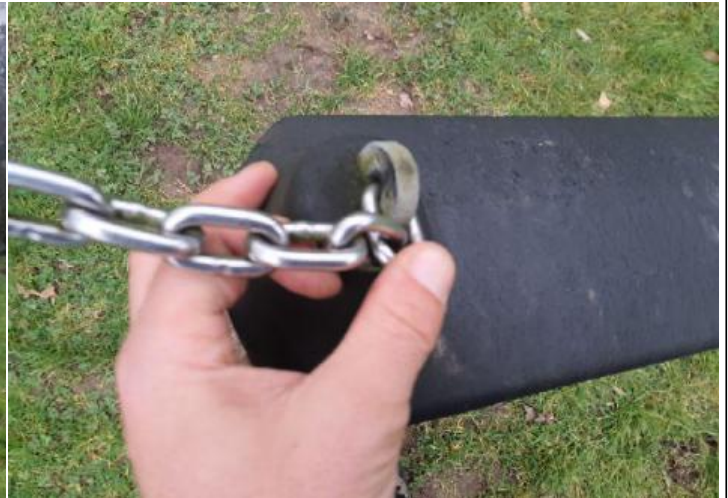
**Finding:** There is some notable evidence of chain wear

**Action:** Monitor for any further deterioration and replace when 40% worn

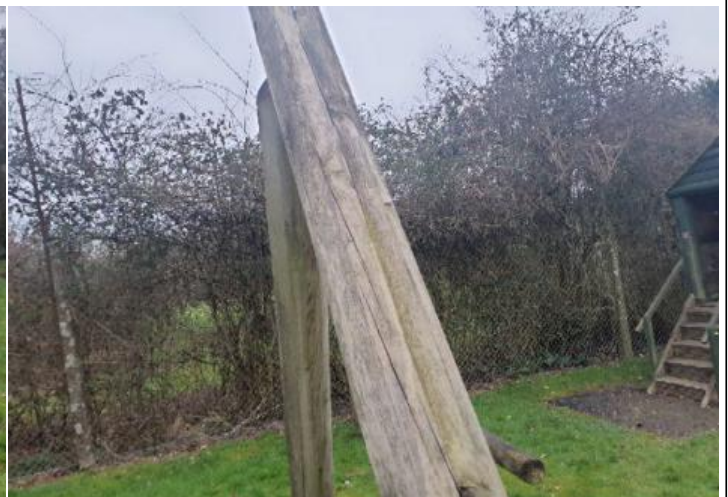
**Finding:** The timber has a number of splits/shakes or air cracks and this may affect the stability or allow water ingress which will accelerate the rotting process

**Action:** Monitor to ensure the splits do not cross through fixing points of the structure and/or cause any instability

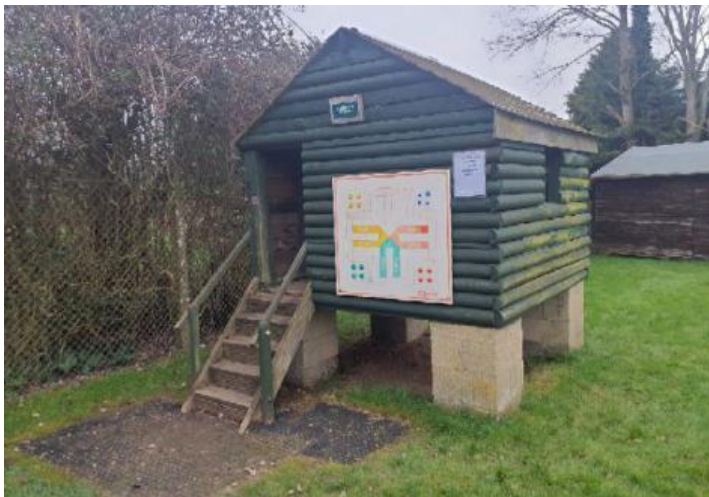
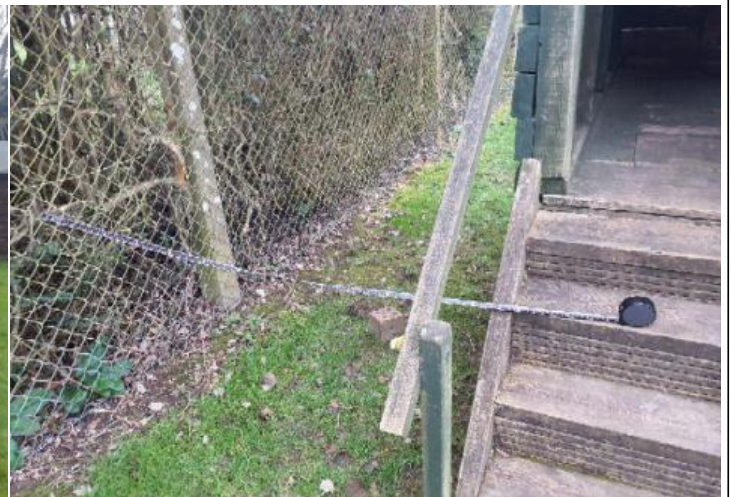
**Finding:** The fence forms a hard object within the falling space of the equipment and there is also insufficient surfacing provided in contravention of BS EN 1176 Part 1  
**Action:** Monitor - no remedial work recommended

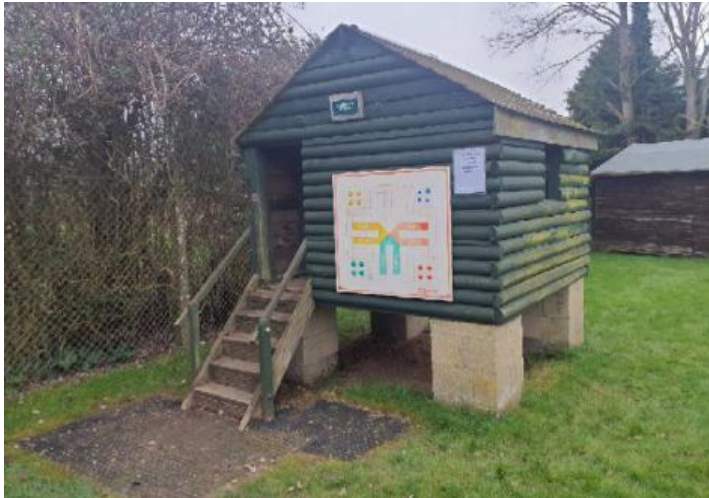
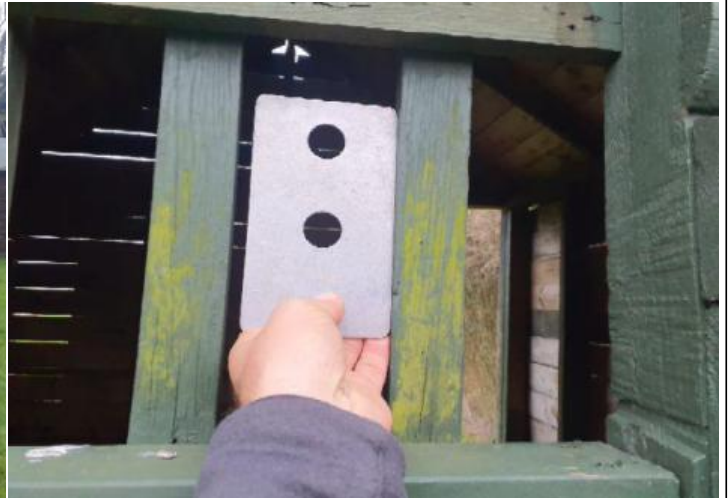
**Finding:** The item fails to meet the requirements of BS EN 1176 Part 1 4.2.7.2 head and neck entrapment in the barriers and/or steps

**Action:** Monitor - No remedial work recommended

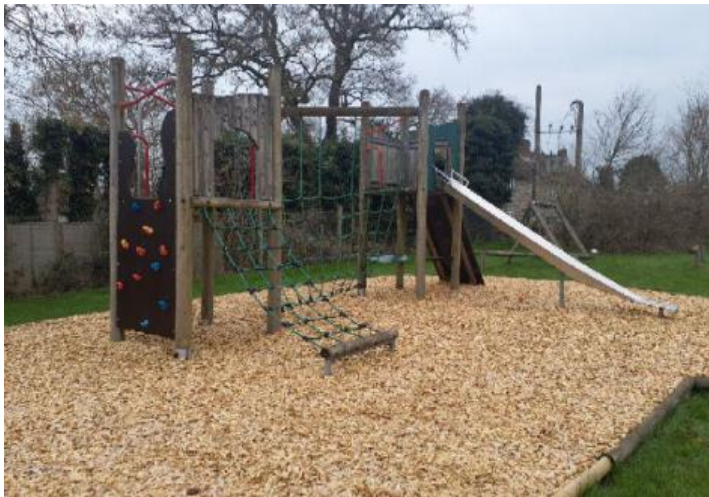
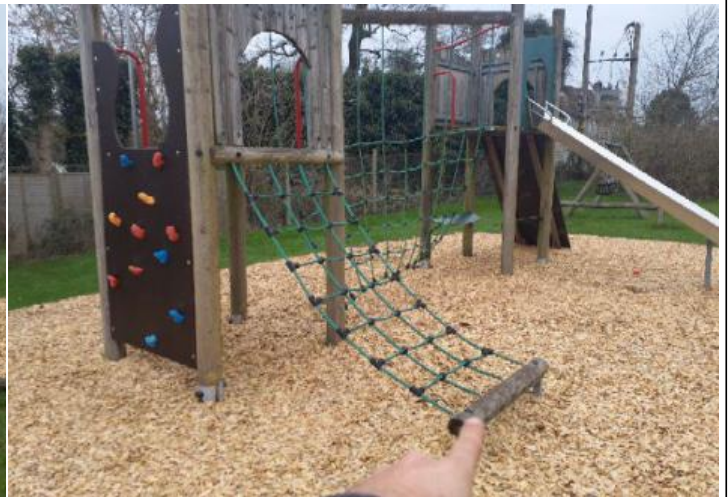
**Finding:** There are falls in excess of 600mm between adjacent components on the structure, in contravention of the recommendations set out in BS EN 1176 Part 1; 4.2.8.4

**Action:** Monitor - No remedial work recommended

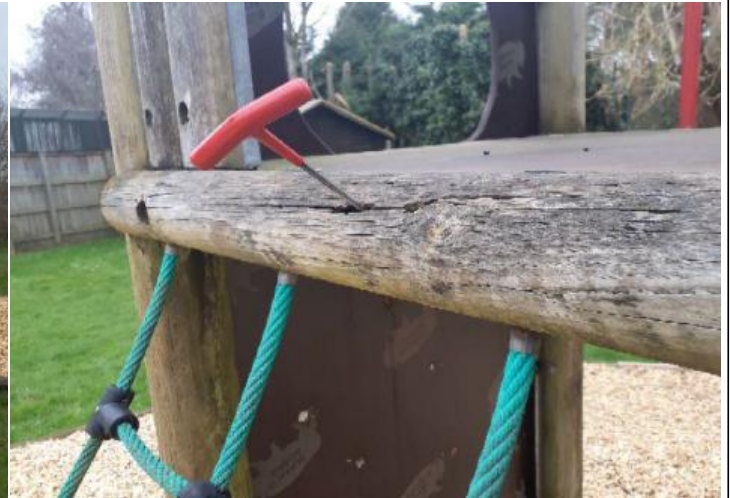
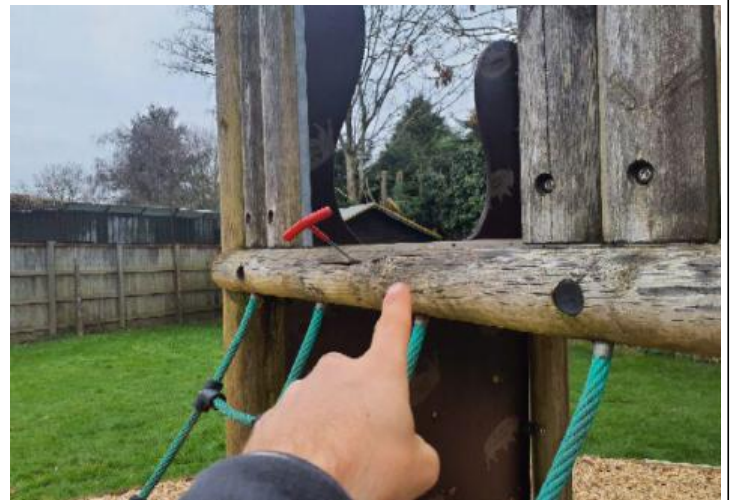
**Finding:** There are areas or parts of the timber on the structure that have rotted

**Action:** Replace all affected timbers

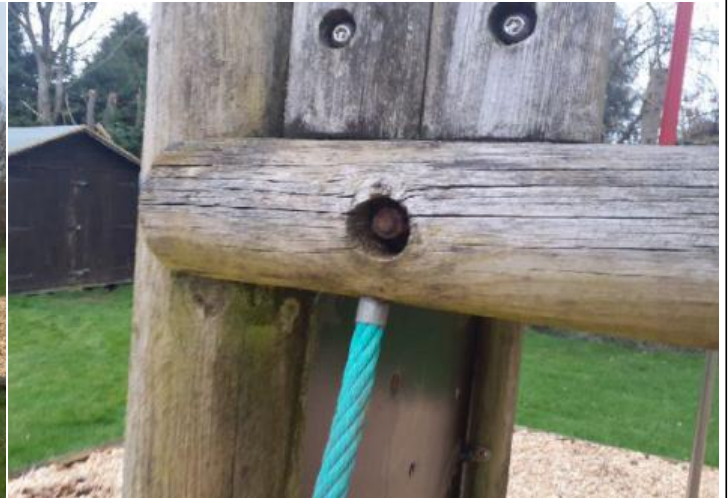
**Finding:** There is/are inserts missing

**Action:** Replace missing inserts

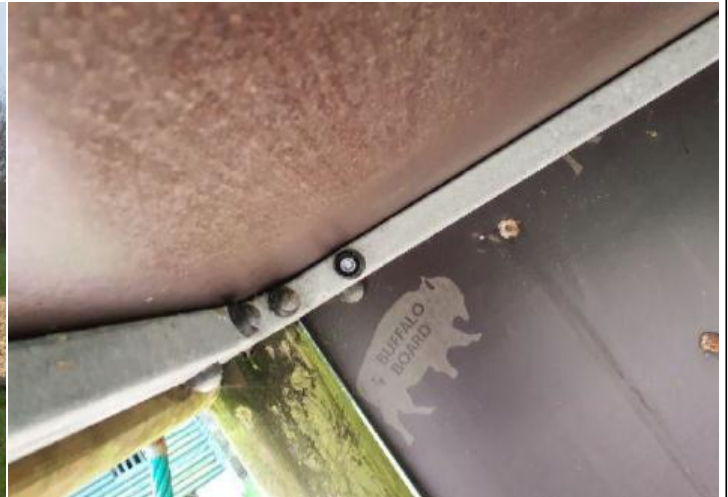
**Finding:** There is/are bolt cap covers missing or damaged on the item

**Action:** Replace missing or damaged bolt cap covers

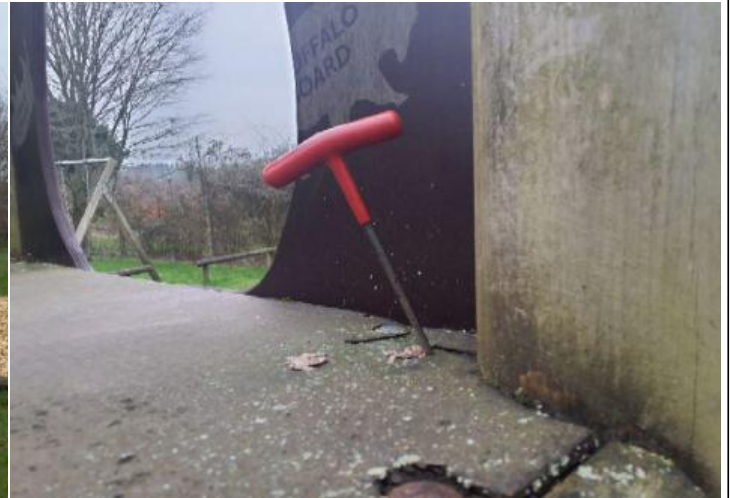
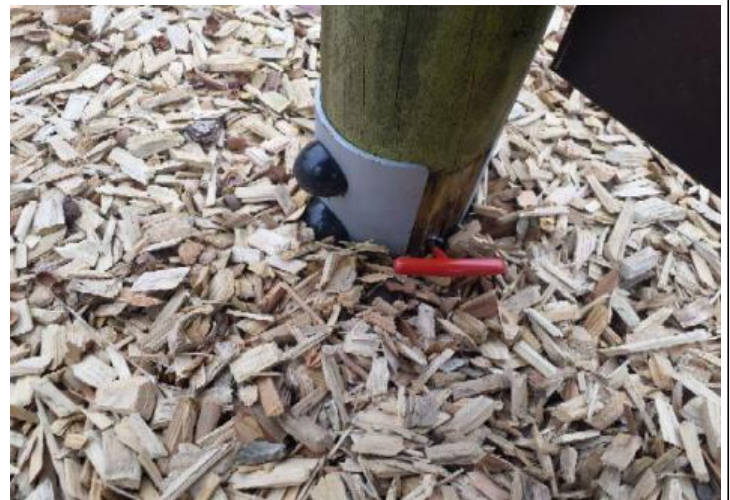
**Finding:** There is some evidence of rot in the timber

**Action:** Monitor for any further deterioration and replace as required

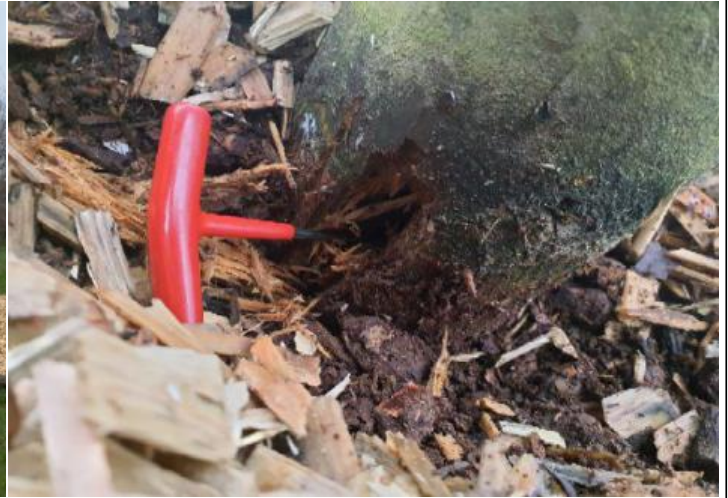
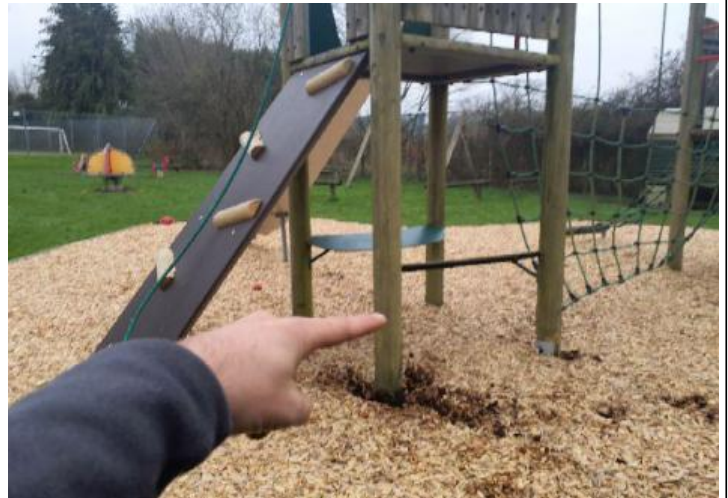
**Finding:** There are areas or parts of the timber on the structure that have rotted (client notified)

**Action:** Replace all affected timbers

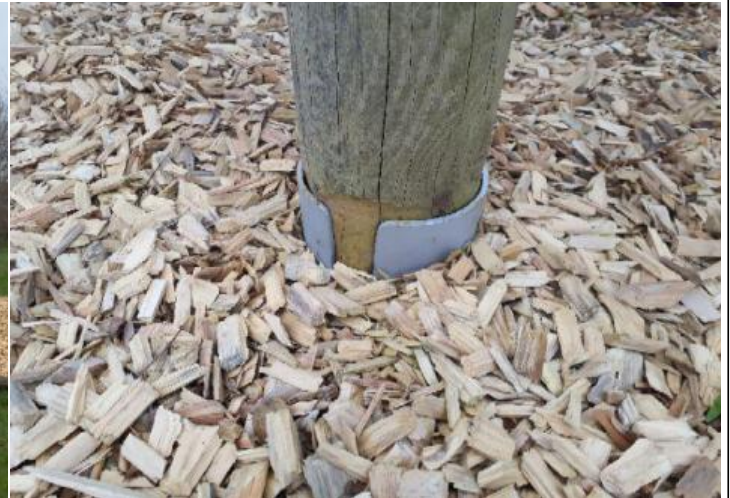
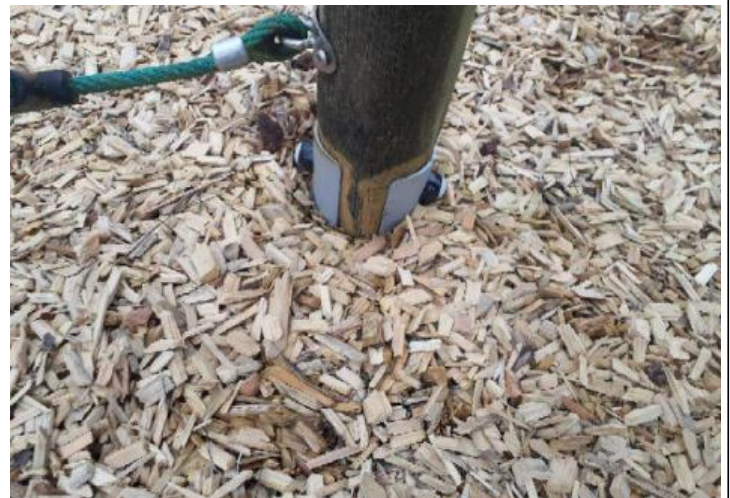
**Finding:** NOTE: Some rotten posts have been reinforced with metal legs instead of being replaced

**Action:** Ensure the repairs are safe and fit for purpose / meet the manufacturers specifications

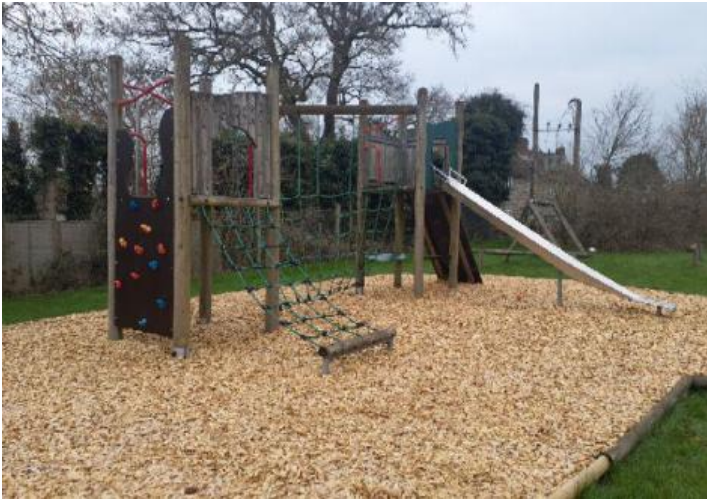
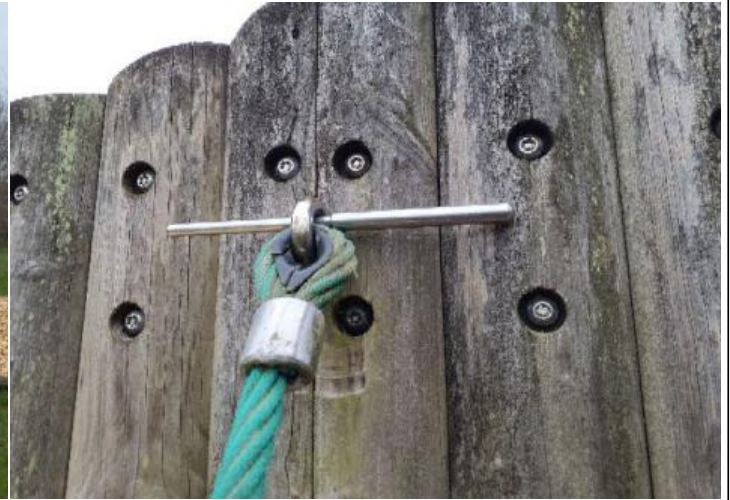
**Finding:** The connecting links are in excess of 8.6mm and less than 12mm and fail the requirements of BS EN 1176 Part 1; clause 4.2.13, Chains

**Action:** Monitor - No remedial work recommended

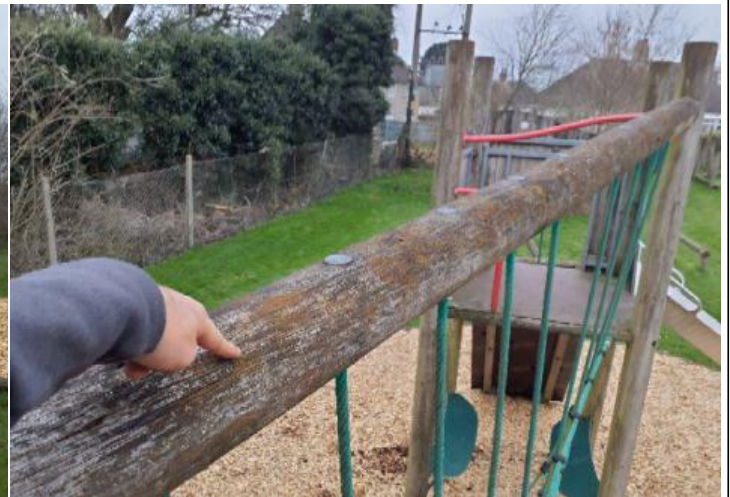
**Finding:** The inspector has some concerns about the internal condition of the timber and was unable to verify the structural integrity without further testing. We recommend a Resi-PD survey to establish the condition of the timber at it's core.

**Action:** Contact the Play Inspection Company office for further information

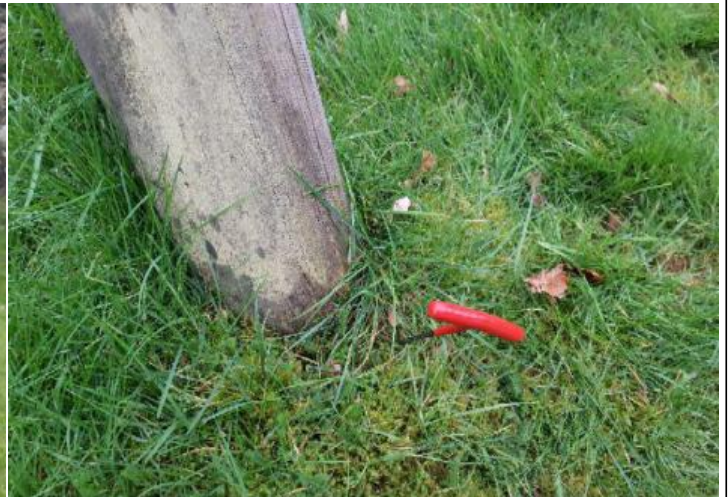
**Finding:** There is some evidence of rot in the timber

**Action:** Monitor for any further deterioration and replace as required

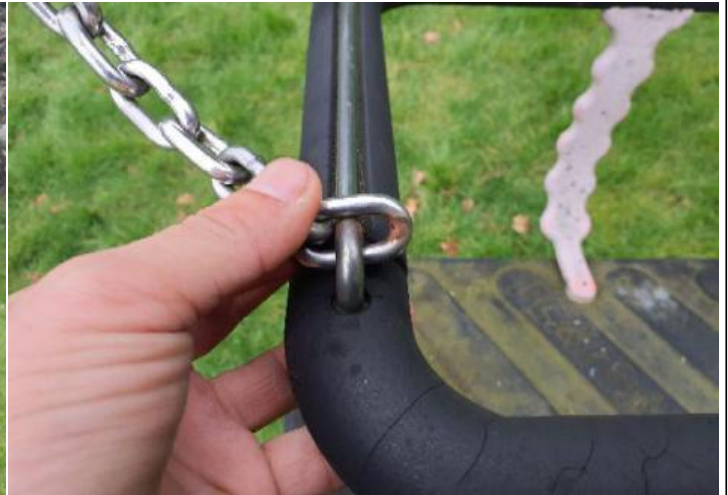
**Finding:** There is some notable evidence of chain wear

**Action:** Monitor for any further deterioration and replace when 40% worn

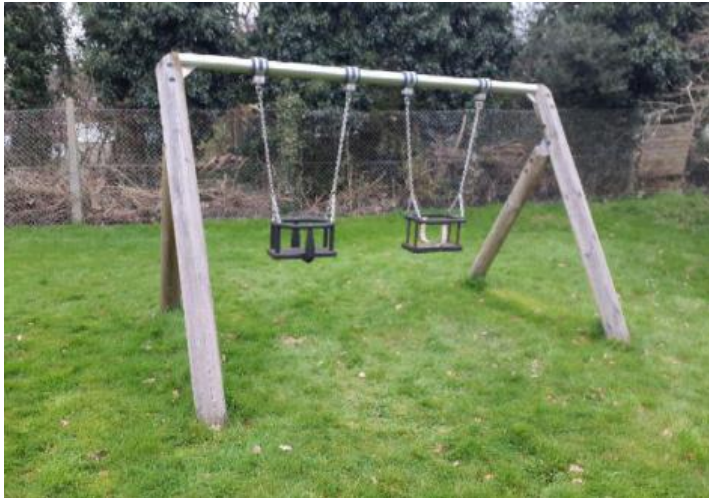
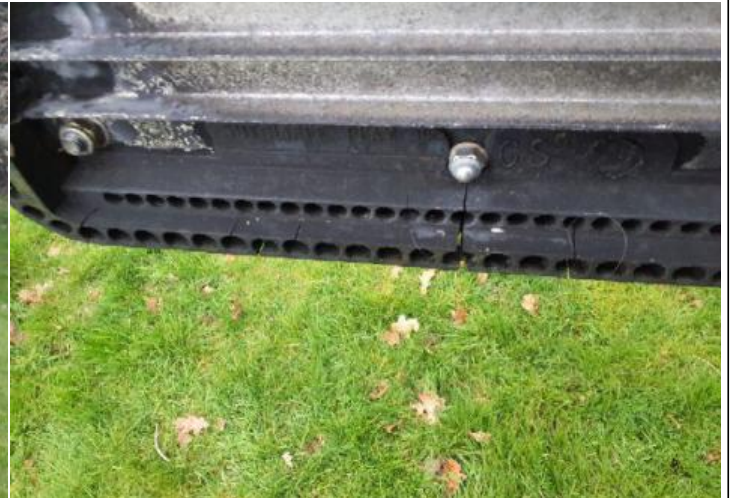
**Finding:** The seat has minor damage or wear

**Action:** Monitor for any further deterioration and replace as required

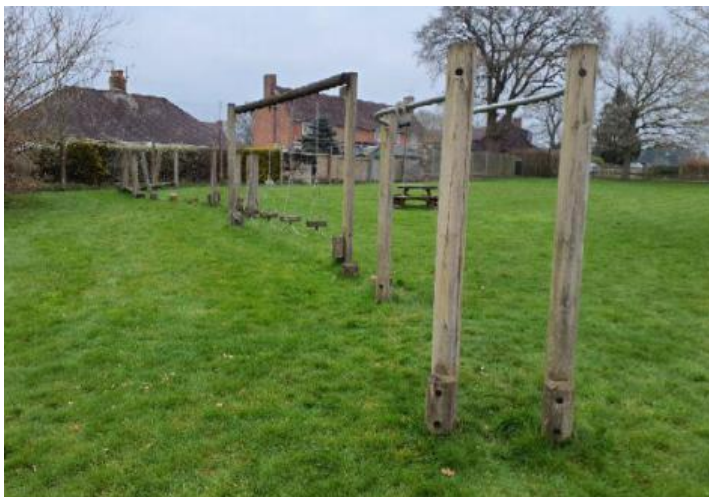
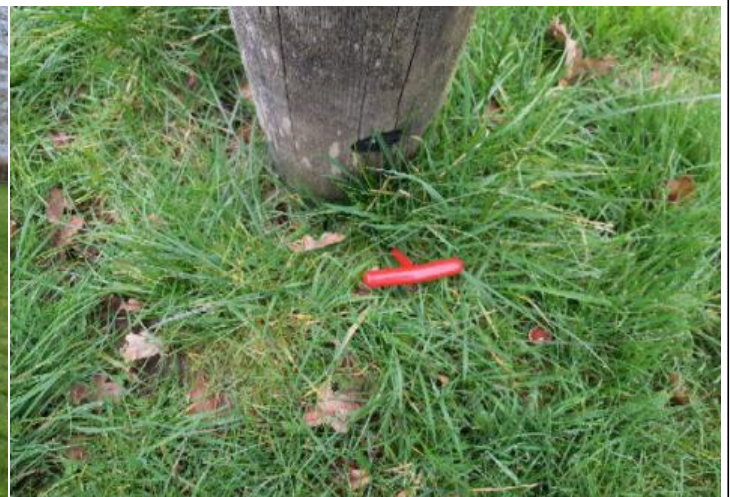
**Finding:** There is some evidence of rot in the timber

**Action:** Monitor for any further deterioration and replace as required

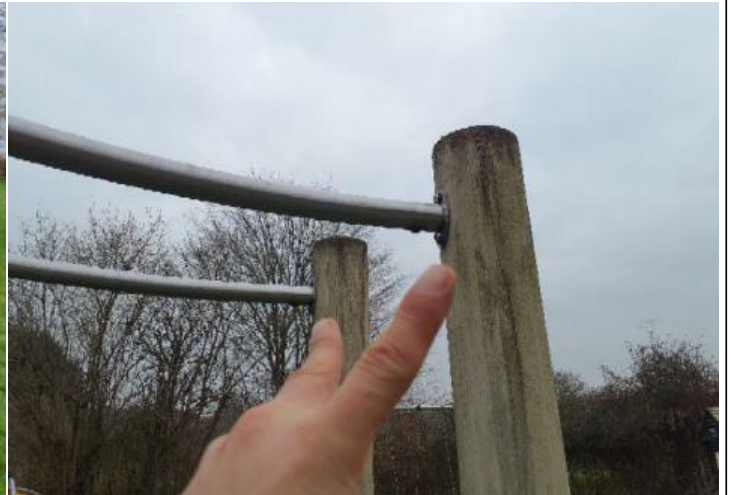
**Finding:** A number of fixing(s) have worked loose

**Action:** Secure all loose fixings

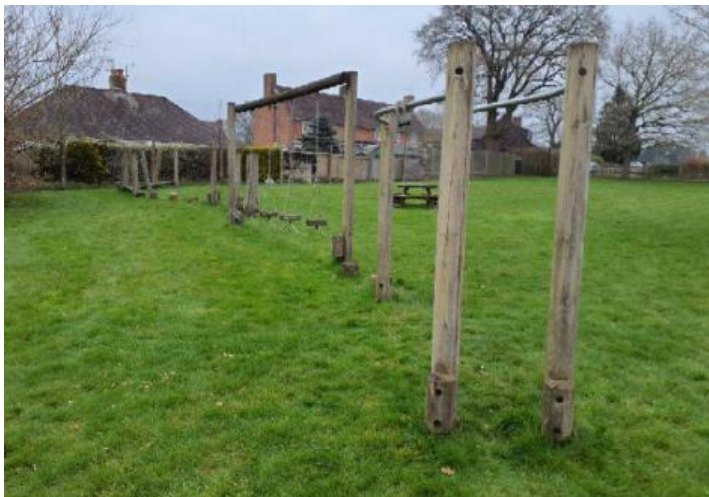
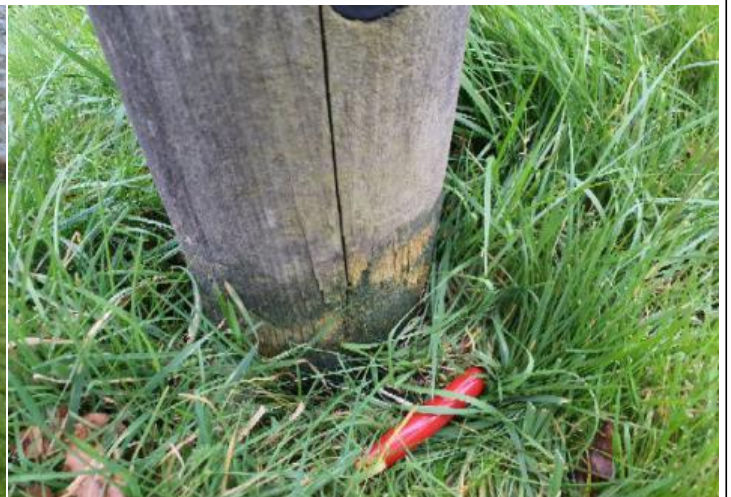
**Finding:** There is some strimmer / machinery damage apparent on the posts, this can penetrate the preservative applied to the timber and accelerate the rotting process

**Action:** Monitor for any deterioration (rot) and replace as required

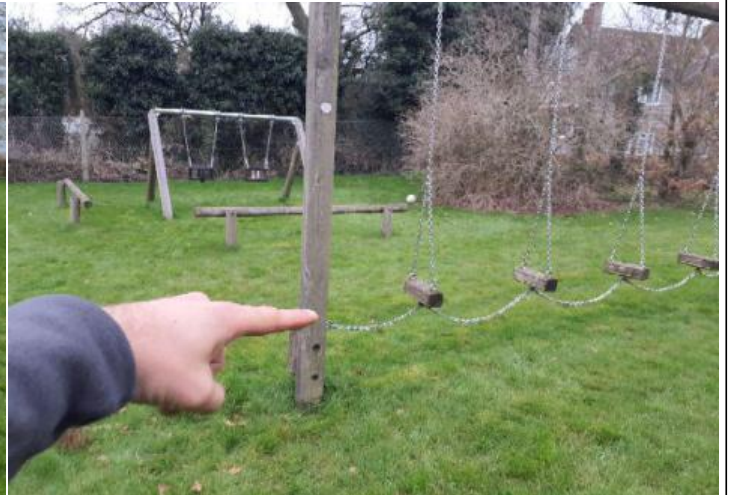
**Finding:** The item is loose in its foundations and there is also evidence of rot

**Action:** Reinstall item to secure or replace if required

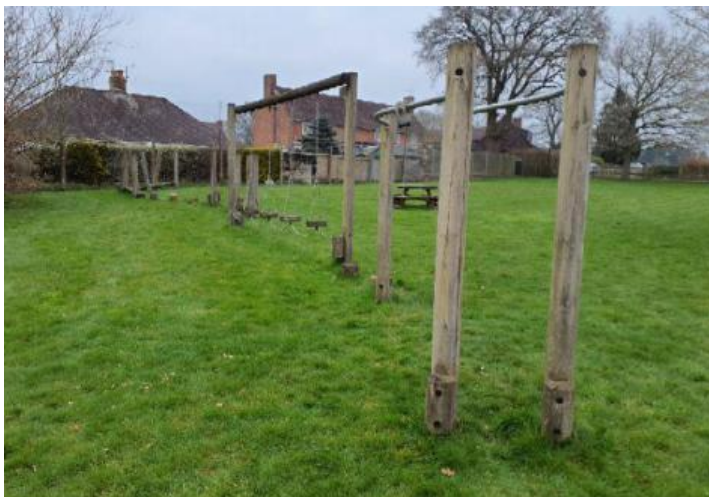
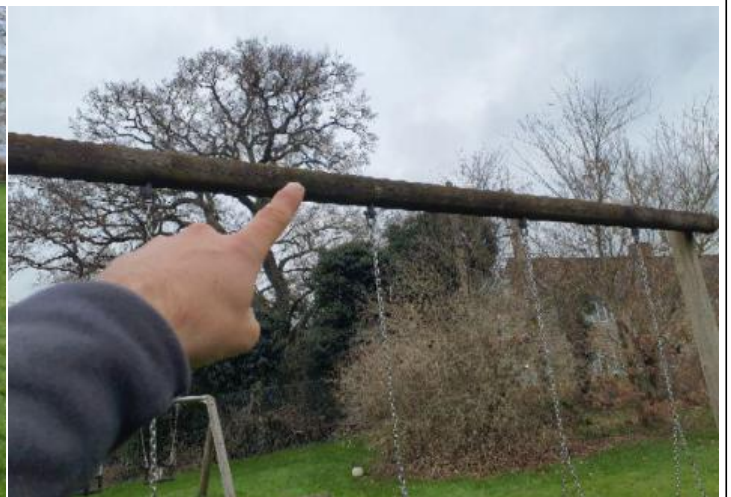
**Finding:** The inspector has some concerns about the internal condition of the timber and was unable to verify the structural integrity without further testing. We recommend a Resi-PD survey to establish the condition of the timber at it's core.

**Action:** Contact the Play Inspection Company office for further information

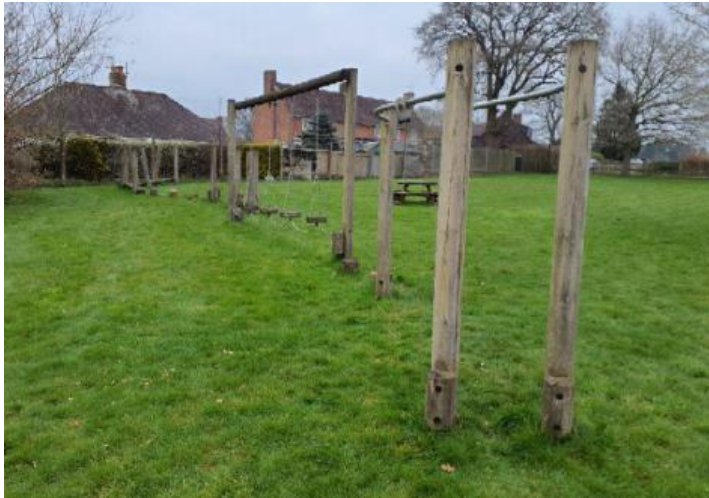
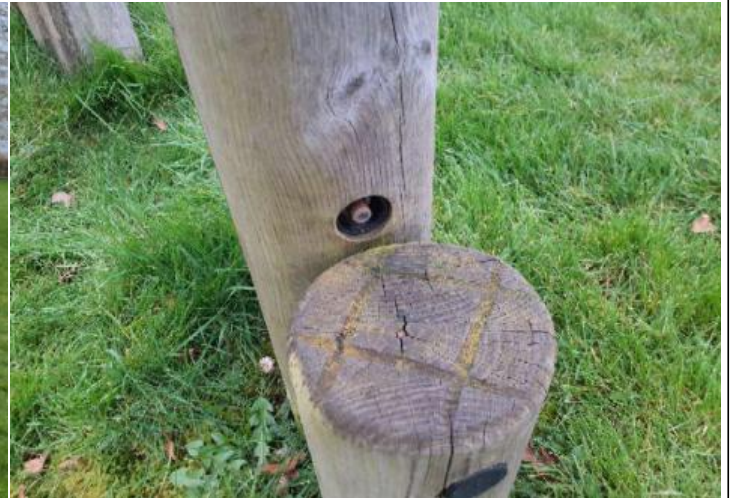
**Finding:** There is/are bolt cap covers missing or damaged on the item

**Action:** Replace missing or damaged bolt cap covers
