## Annual Inspection

Winchester City Council

The Jubilee RG (Bramdean and Hinton Ampner PC)

Off Woodlane Close, Bramdean, Winchester,  
Hampshire, SO24 0JR

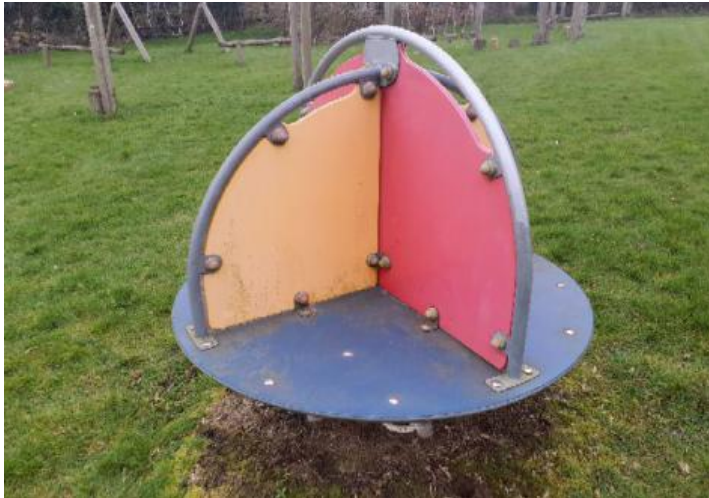
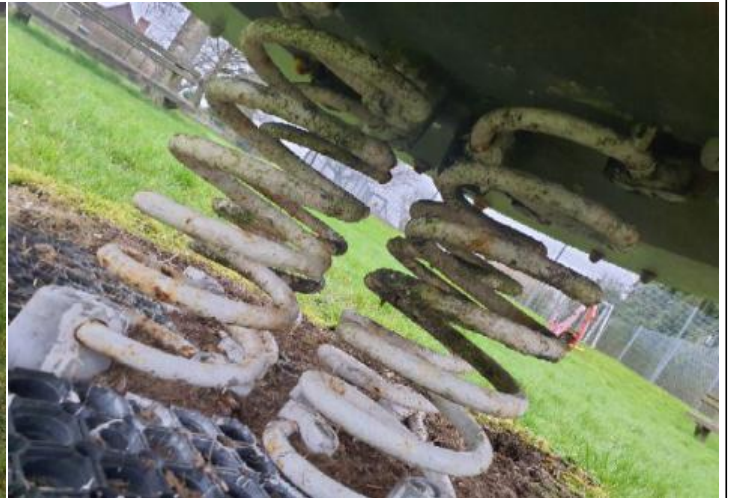
**Finding:** The paintwork on the spring has been damaged or worn exposing the metal underneath which is rusting  
**Action:** Treat any rusting components and repaint

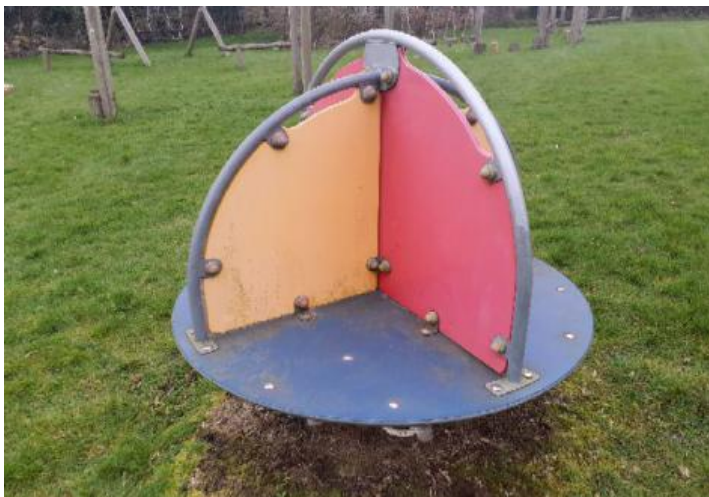
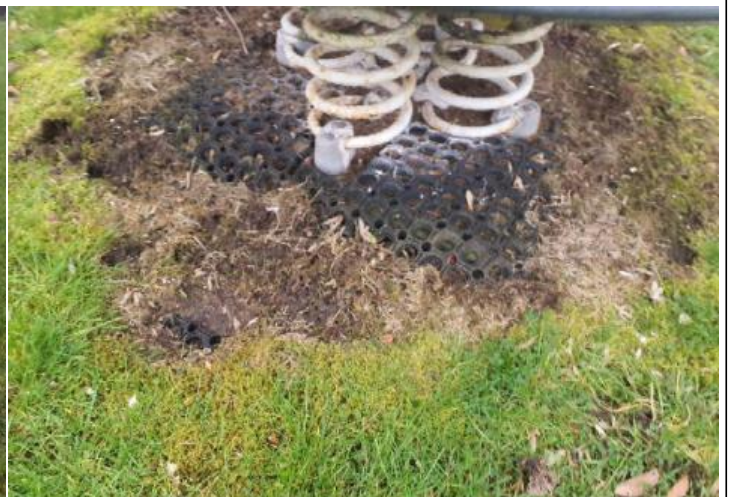
**Finding:** The spring clamps are loose  
**Action:** Tighten all loose fixings

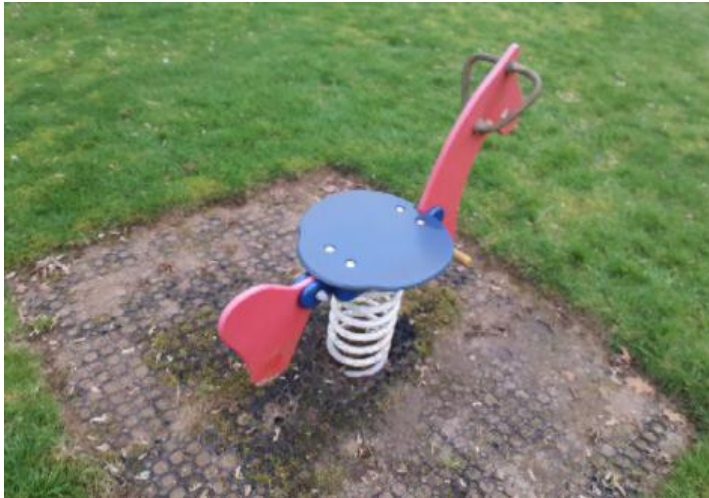
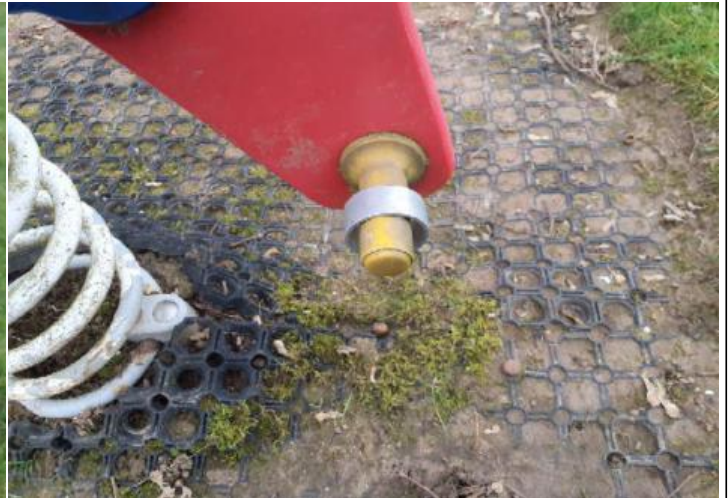
**Finding:** The end of handgrips and/or footrests have a cross section of less than 15cm<sup>2</sup> and fail to meet the requirements of BS EN 1176 Part 6  
**Action:** Monitor - No remedial work recommended

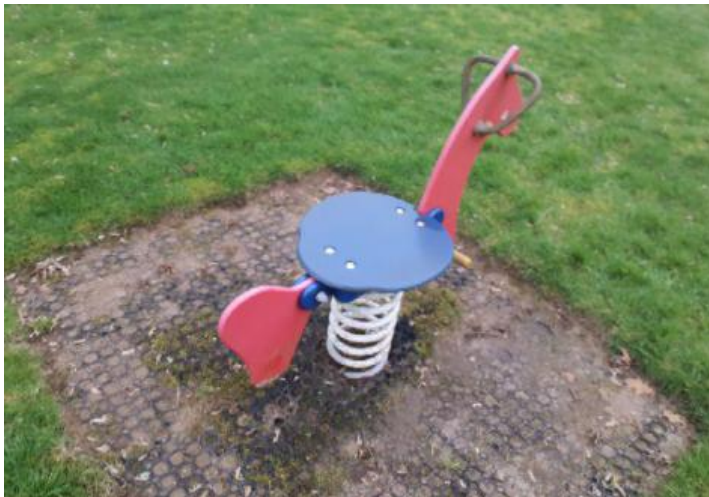
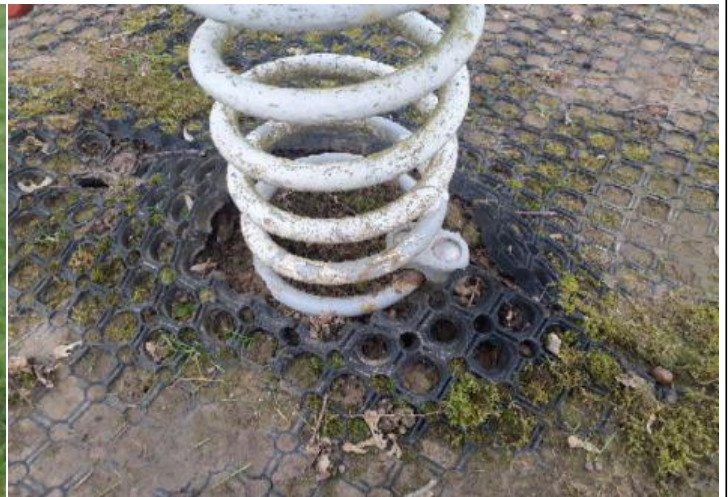
**Finding:** The paintwork on the spring has been damaged or worn exposing the metal underneath which is rusting  
**Action:** Treat any rusting components and repaint

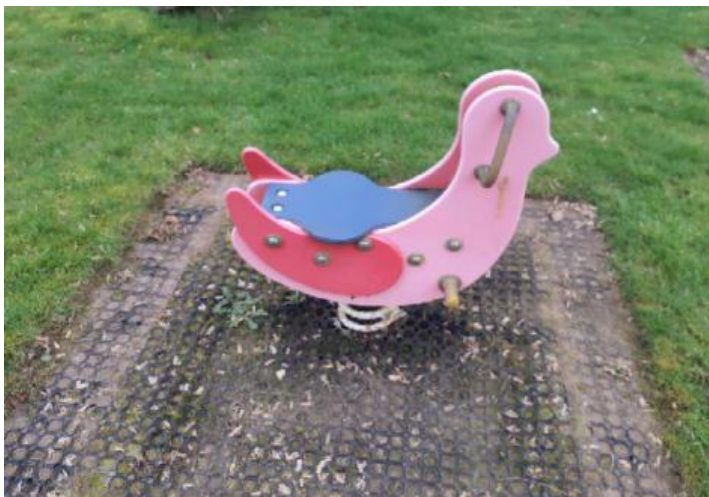
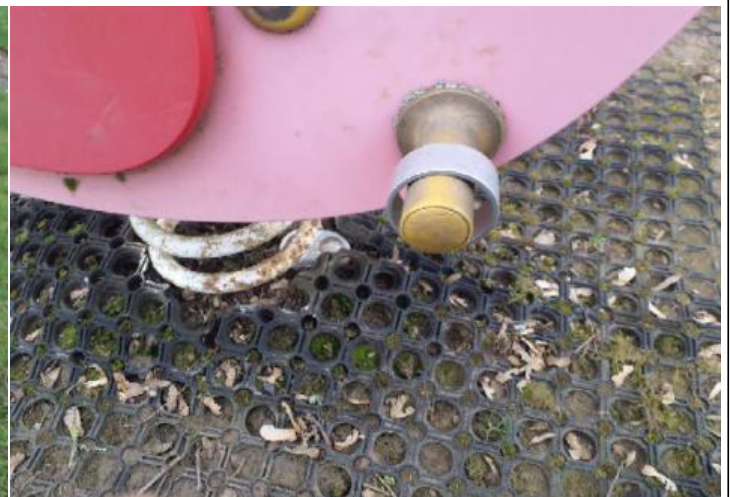
**Finding:** The end of handgrips and/or footrests have a cross section of less than 15cm<sup>2</sup> and fail to meet the requirements of BS EN 1176 Part 6 **Action:** Monitor - No remedial work recommended

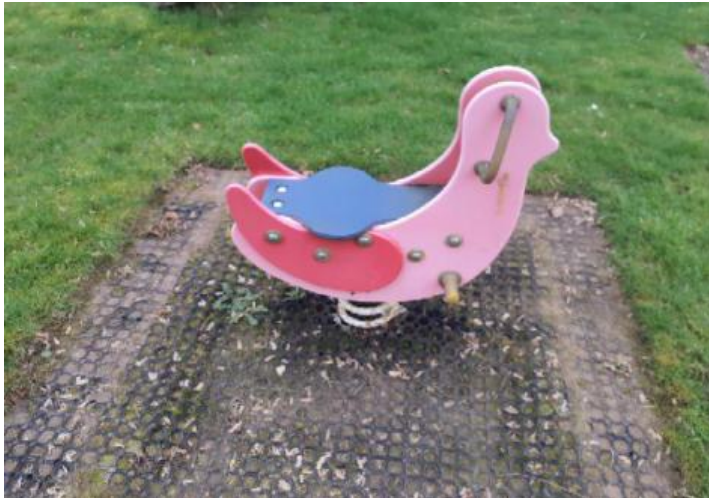
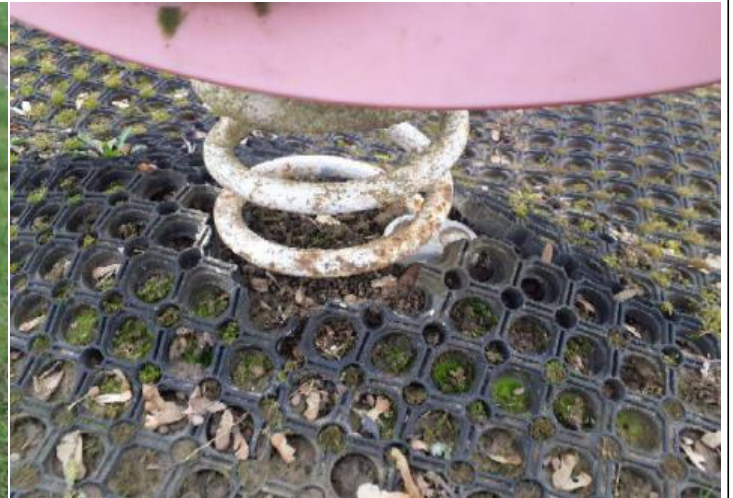
**Finding:** The paintwork on the spring has been damaged or worn exposing the metal underneath which is rusting  
**Action:** Treat any rusting components and repaint

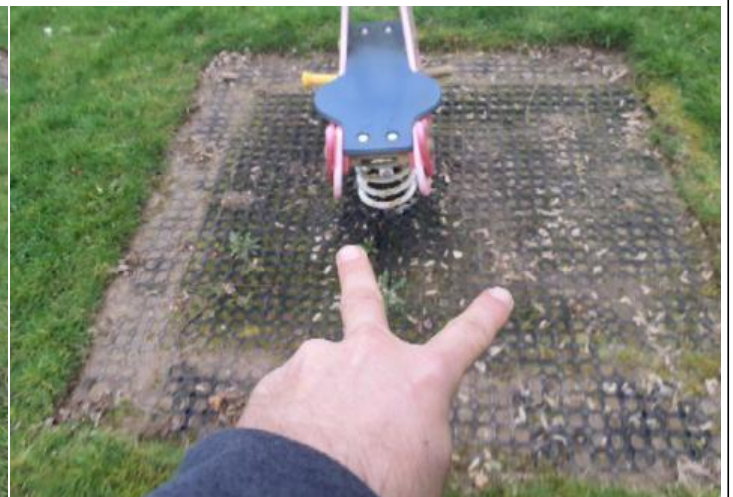
**Finding:** The surface has subsided in some areas  
**Action:** Monitor for any further deterioration and repair as required
