Annual Inspection

The Jubilee RG (Bramdean and Hinton Ampner PC)

Inspection Ref: 1299819

Inspected: 25-February-2021 - 14:29 by Daryl Cormack

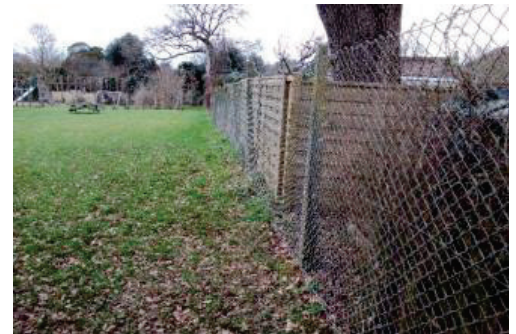
Item: Fence - Chainlink
Manufacturer: Owner/Operator
Surface Type: Grass
Item Quantity: 1
Equipment Compliance: N/A
Surface Area Compliance: N/A

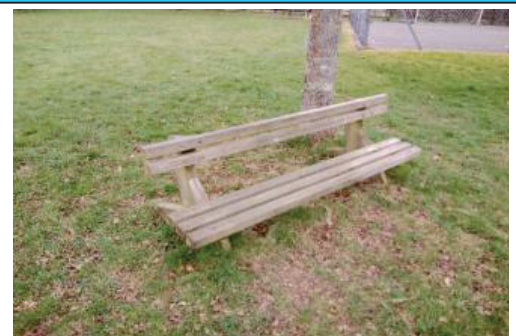
Item: Bench
Manufacturer: Owner/Operator
Surface Type: Grass
Item Part Number:
Item Quantity: 3
Equipment Compliance: N/A
Surface Area Compliance: N/A
Total Findings: 1

This item is satisfactory - no work required -

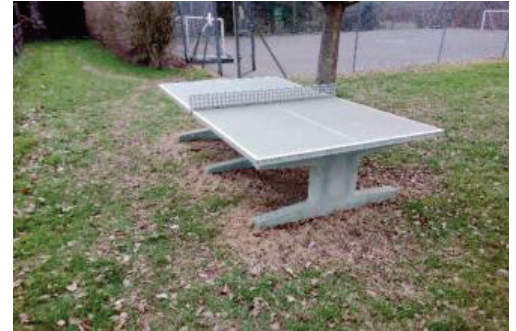
Item: Table Tennis
Manufacturer: Unknown
Surface Type: Grass
Item Quantity: 1
Equipment Compliance: N/A
Surface Area Compliance: N/A

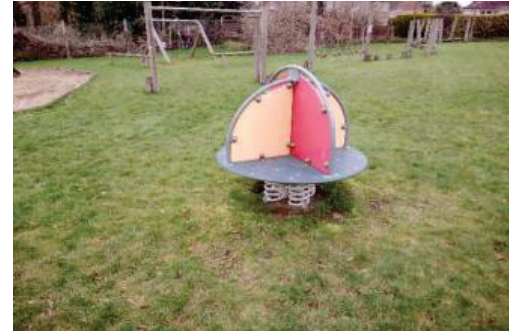
Item: Spring Ark
Manufacturer: Unknown
Surface Type: Grass Matrix Tiles
Item Quantity: 1
Equipment Compliance: Yes
Surface Area Compliance: Yes

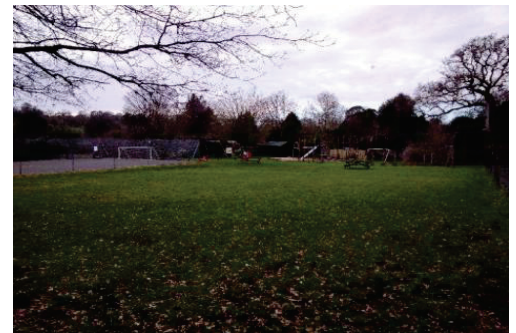
Item: Site General
Manufacturer: Owner/Operator
Surface Type: Grass
Item Quantity: 1
Equipment Compliance: N/A
Surface Area Compliance: N/A
