the **play inspection** company

Annual Inspection

The Jubilee RG (Bramdean and Hinton Ampner PC)

Inspection Ref: 1999059

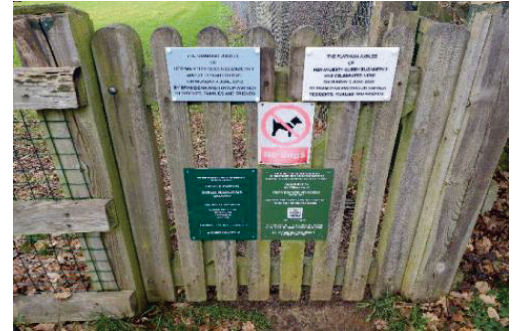
i 8 - Low Risk

Item: Gate
Manufacturer: Not Identified
Surface Type: Grass
Item Quantity: 1
Equipment Compliance: N/A
Surface Area Compliance: N/A

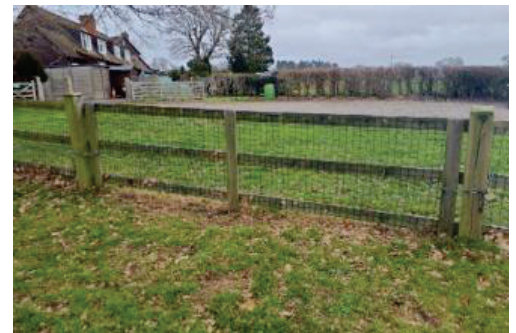
i 4 - Very Low Risk

Item: Gate - Maintenance
Manufacturer: Not Identified
Surface Type: Grass
Item Quantity: 1
Equipment Compliance: N/A
Surface Area Compliance: N/A

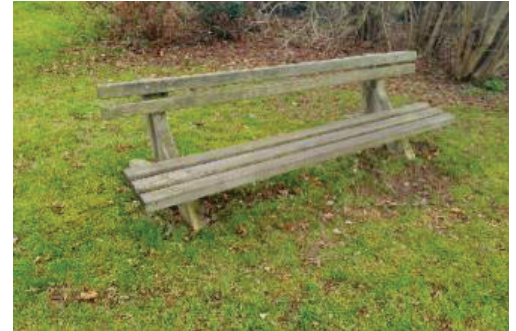
i 4 - Very Low Risk

Item: Bench
Manufacturer: Not Identified
Surface Type: Grass
Item Quantity: 3
Equipment Compliance: N/A
Surface Area Compliance: N/A

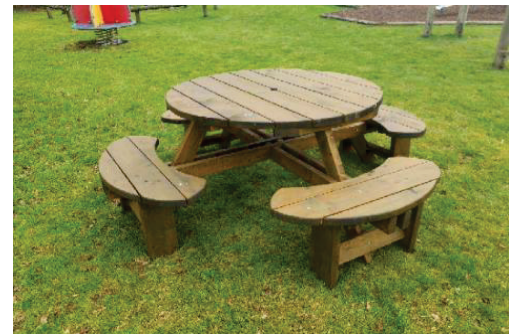
i 8 - Low Risk

Item: Picnic Table
Manufacturer: Not Identified
Surface Type: Grass
Item Quantity: 1
Equipment Compliance: N/A
Surface Area Compliance: N/A
