## Annual Inspection

Winchester City Council

The Jubilee RG (Bramdean and Hinton Ampner PC)

Off Woodlane Close, Bramdean, Winchester,  
Hampshire, SO24 0JR

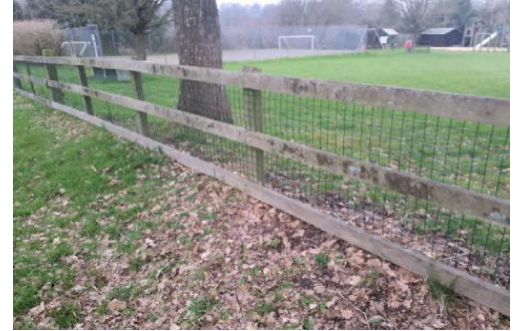
**Item:** Fence - Timber & Mesh Infill  
**Manufacturer:** Not Identified  
**Surface Type:** Grass  
**Item Quantity:** 1  
**Equipment Compliance:** N/A  
**Surface Area Compliance:** N/A

There are areas or parts of the timber on the structure that have rotted - Replace all affected timbers

There are a number of loose posts around the fence - Monitor for any further deterioration and reset as required

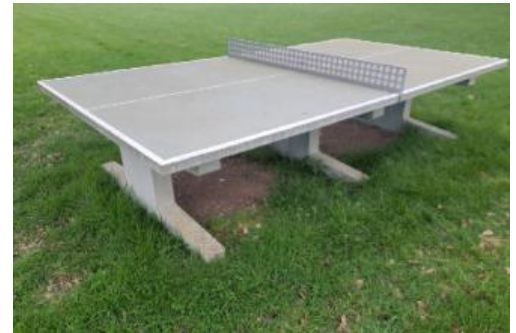
**Item:** Table Tennis  
**Manufacturer:** Not Identified  
**Surface Type:** Grass  
**Item Quantity:** 1  
**Equipment Compliance:** N/A  
**Surface Area Compliance:** N/A  
**Life Expectancy:** 5 -10 Years  
**Total Findings:** 1

This item is satisfactory - no work required -

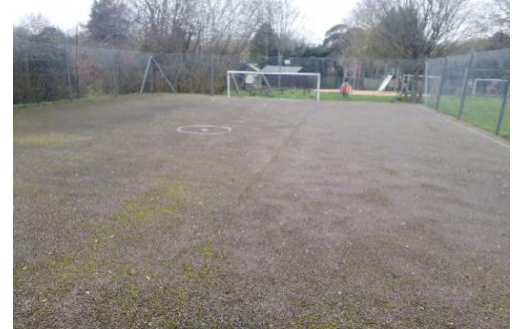
**Item:** Ball Games Area  
**Manufacturer:** Not Identified  
**Surface Type:** Bitmac  
**Item Quantity:** 1  
**Equipment Compliance:** No  
**Surface Area Compliance:** N/A  
**Life Expectancy:** >10 Years  
**Total Findings:** 7

A clearly visible facility sign should be provided in a prominent position with the wording as detailed BS EN 15312- the equipment is not intended for children less than 3 years old- the warning - Do not climb on the framework or nets- the warning - Do not hang on the ring (if provided)- the warning - Do not wear rings or other jewellery- name and telephone number of the administrator- number to call in case of accident - Provide signage to BS EN 15312

The item is slightly loose in its foundations - Monitor for any further deterioration and repair as required

There is algae, silt or moss growth on the surface resulting in slippery conditions - Clean and treat appropriately

There is/are finger entrapments in the fence and the item fails to meet the requirements of BS EN 15312 Clause 4.4.2.2 Entrapment of fingers - Monitor - No remedial work recommended

There are a number of loose posts around the fence - Monitor for any further deterioration and reset as required

There is or are fixings missing on the item - Replace all missing fixings

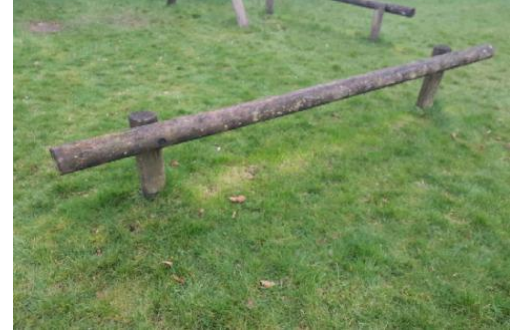
**Item:** Swing Barrier  
**Manufacturer:** Playdale Playgrounds Ltd  
**Surface Type:** Grass  
**Item Part Number:**  
**Item Quantity:** 6  
**Equipment Compliance:** N/A  
**Surface Area Compliance:** N/A  
**Total Findings:** 2

There are areas or parts of the timber on the structure that have rotted - Replace all affected timbers

There is some evidence of rot in the timber - Monitor for any further deterioration and replace as required

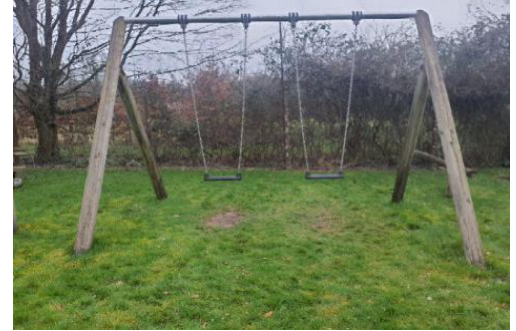
**Item:** 1 Bay 2 Seat (Flat)  
**Manufacturer:** Playdale Playgrounds Ltd  
**Surface Type:** Grass Matrix Tiles  
**Item Quantity:** 1  
**Equipment Compliance:** Yes  
**Surface Area Compliance:** Yes  
**Life Expectancy:** 3 - 5 Years  
**Total Findings:** 6

There is some evidence of rot in the timber - Monitor for any further deterioration and replace as required

There are areas or parts of the timber on the structure that have rotted - Replace all affected timbers

The seat has minor damage or wear - Monitor for any further deterioration and replace as required

There is some notable evidence of chain wear - Monitor for any further deterioration and replace when 40% worn

The timber has a number of splits/shakes or air cracks and this may affect the stability or allow water ingress which will accelerate the rotting process - Monitor to ensure the splits do not cross through fixing points of the structure and/or cause any instability

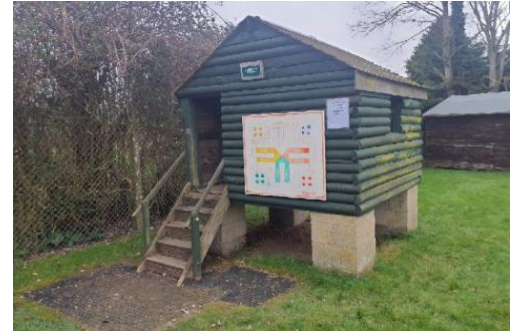
**Item:** Playhouse  
**Manufacturer:** Not Identified  
**Surface Type:** Grass  
**Item Quantity:** 1  
**Equipment Compliance:** No  
**Surface Area Compliance:** No  
**Life Expectancy:** 5 -10 Years  
**Total Findings:** 5

This equipment has not been designed or installed to meet with the requirements of BS EN 1176 for public playground equipment; we have however used our knowledge of these standards to assist in forming the basis of our report. - The equipment should either be removed from use or written confirmation be sought from the supplier concerning the suitability of this equipment for the intended use

The item fails to meet the requirements of BS EN 1176 Part 1 4.2.7.2 head and neck entrapment in the barriers and/or steps - Monitor - No remedial work recommended

The fence forms a hard object within the falling space of the equipment and there is also insufficient surfacing provided in contravention of BS EN 1176 Part 1 - Monitor - no remedial work recommended

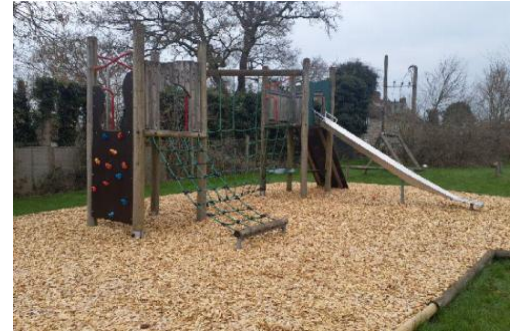
**Item:** Multi Play (Junior)  
**Manufacturer:** Playdale Playgrounds Ltd  
**Surface Type:** Bark Mulch  
**Item Quantity:** 1  
**Equipment Compliance:** No  
**Surface Area Compliance:** Yes  
**Life Expectancy:** 5 -10 Years  
**Total Findings:** 10

There are falls in excess of 600mm between adjacent components on the structure, in contravention of the recommendations set out in BS EN 1176 Part 1; 4.2.8.4 - Monitor - No remedial work recommended

There are areas or parts of the timber on the structure that have rotted - Replace all affected timbers

There is/are inserts missing - Replace missing inserts

There is/are bolt cap covers missing or damaged on the item - Replace missing or damaged bolt cap covers

There is some evidence of rot in the timber - Monitor for any further deterioration and replace as required

There are areas or parts of the timber on the structure that have rotted (client notified) - Replace all affected timbers

NOTE: Some rotten posts have been reinforced with metal legs instead of being replaced - Ensure the repairs are safe and fit for purpose / meet the manufacturers specifications

The connecting links are in excess of 8.6mm and less than 12mm and fail the requirements of BS EN 1176 Part 1; clause 4.2.13, Chains - Monitor - No remedial work recommended

The inspector has some concerns about the internal condition of the timber and was unable to verify the structural integrity without further testing. We recommend a Resi-PD survey to establish the condition of the timber at it's core. - Contact the Play Inspection Company office for further information

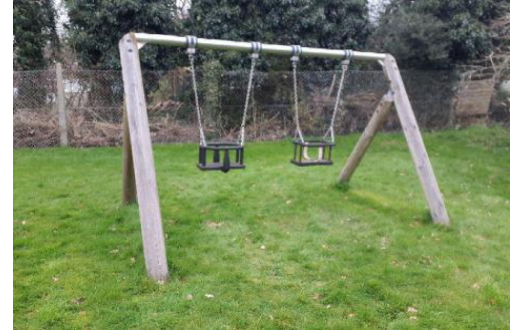
**Item:** 1 Bay 2 Seat (Cradle)  
**Manufacturer:** Playdale Playgrounds Ltd  
**Surface Type:** Grass  
**Item Quantity:** 1  
**Equipment Compliance:** Yes  
**Surface Area Compliance:** Yes  
**Life Expectancy:** 3 - 5 Years  
**Total Findings:** 4

There is some evidence of rot in the timber - Monitor for any further deterioration and replace as required

There is some notable evidence of chain wear - Monitor for any further deterioration and replace when 40% worn

The seat has minor damage or wear - Monitor for any further deterioration and replace as required

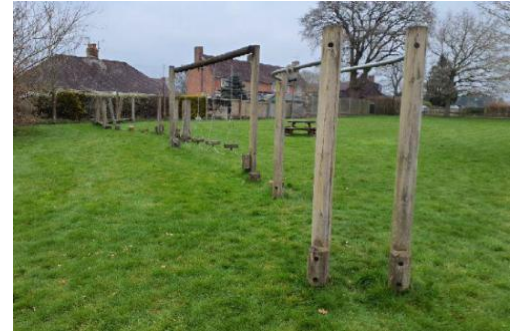
**Item:** Activity Trail  
**Manufacturer:** Playdale Playgrounds Ltd  
**Surface Type:** Grass Matrix Tiles  
**Item Quantity:** 1  
**Equipment Compliance:** Yes  
**Surface Area Compliance:** Yes  
**Life Expectancy:** 3 - 5 Years  
**Total Findings:** 7

There is some evidence of rot in the timber - Monitor for any further deterioration and replace as required

A number of fixing(s) have worked loose - Secure all loose fixings

There is some strimmer / machinery damage apparent on the posts, this can penetrate the preservative applied to the timber and accelerate the rotting process - Monitor for any deterioration (rot) and replace as required

The item is loose in its foundations and there is also evidence of rot - Reinstall item to secure or replace if required

The inspector has some concerns about the internal condition of the timber and was unable to verify the structural integrity without further testing. We recommend a Resi-PD survey to establish the condition of the timber at it's core. - Contact the Play Inspection Company office for further information

There is/are bolt cap covers missing or damaged on the item - Replace missing or damaged bolt cap covers

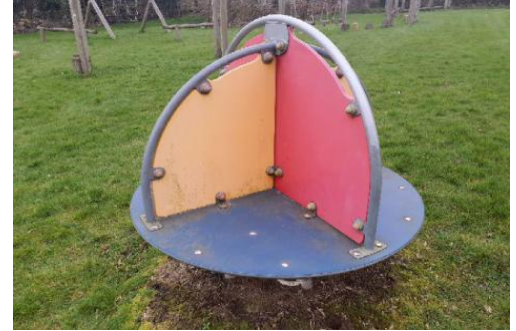
**Item:** Spring Ark  
**Manufacturer:** Playdale Playgrounds Ltd  
**Surface Type:** Grass Matrix Tiles  
**Item Quantity:** 1  
**Equipment Compliance:** Yes  
**Surface Area Compliance:** Yes  
**Life Expectancy:** 5 -10 Years  
**Total Findings:** 2

The paintwork on the spring has been damaged or worn exposing the metal underneath which is rusting - Treat any rusting components and repaint

The spring clamps are loose - Tighten all loose fixings

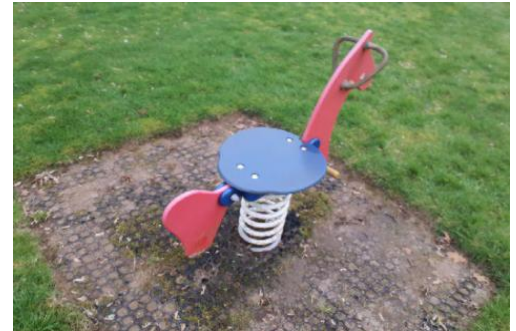
**Item:** Spring Horse  
**Manufacturer:** Ledon  
**Surface Type:** Grass Matrix Tiles  
**Item Quantity:** 1  
**Equipment Compliance:** No  
**Surface Area Compliance:** Yes  
**Life Expectancy:** 5 -10 Years  
**Total Findings:** 3

The end of handgrips and/or footrests have a cross section of less than 15cm<sup>2</sup> and fail to meet the requirements of BS EN 1176 Part 6 - Monitor - No remedial work recommended

The paintwork on the spring has been damaged or worn exposing the metal underneath which is rusting - Treat any rusting components and repaint

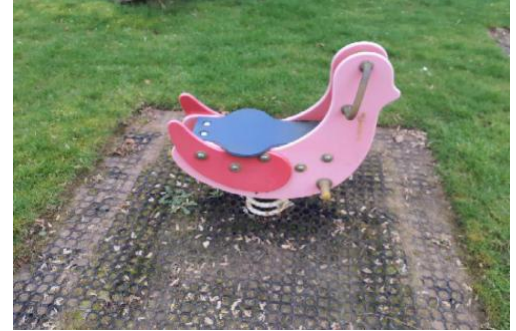
**Item:** Spring Chicken  
**Manufacturer:** Ledon  
**Surface Type:** Grass Matrix Tiles  
**Item Quantity:** 1  
**Equipment Compliance:** No  
**Surface Area Compliance:** Yes  
**Life Expectancy:** 5 -10 Years  
**Total Findings:** 3

The end of handgrips and/or footrests have a cross section of less than 15cm<sup>2</sup> and fail to meet the requirements of BS EN 1176 Part 6 - Monitor - No remedial work recommended

The paintwork on the spring has been damaged or worn exposing the metal underneath which is rusting - Treat any rusting components and repaint

The surface has subsided in some areas - Monitor for any further deterioration and repair as required

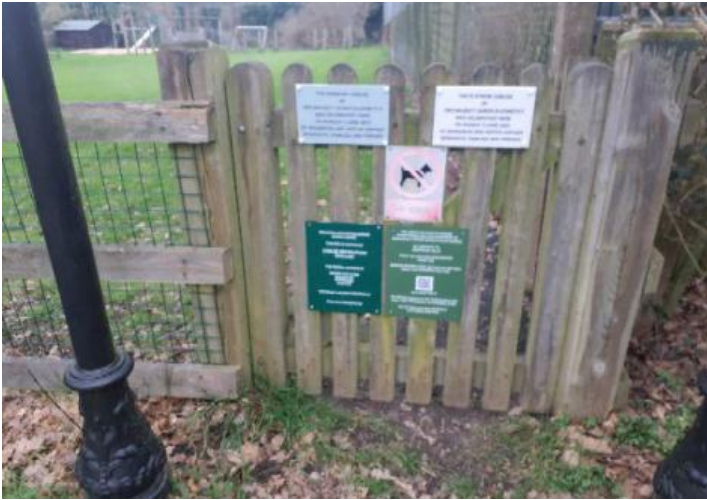
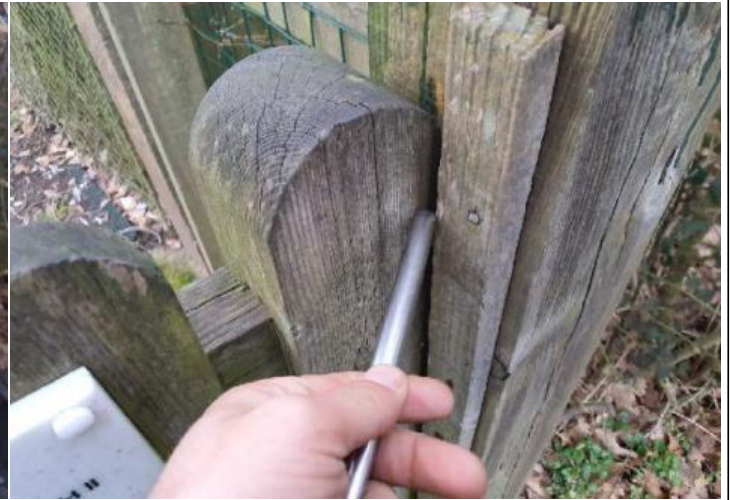
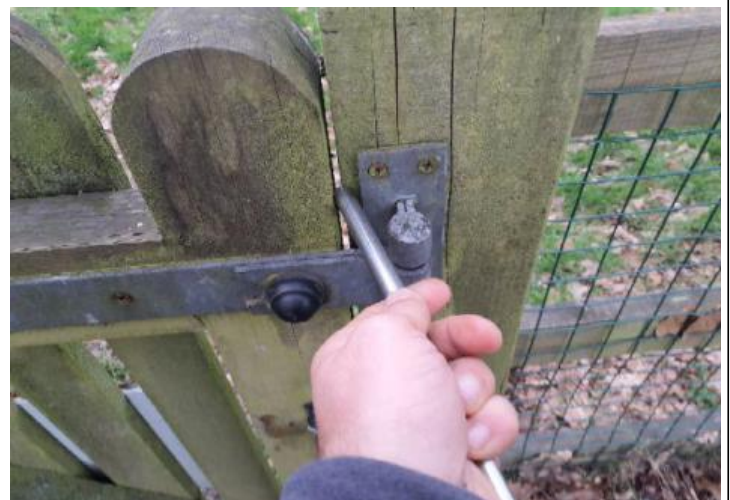
**Item:** Gates - Gate  
**Manufacturer:** Not Identified

**Finding:** There are openings that are less than 12mm that could trap or crush fingers

**Action:** Provide a 12mm gap throughout full range of motion at both sides of gate

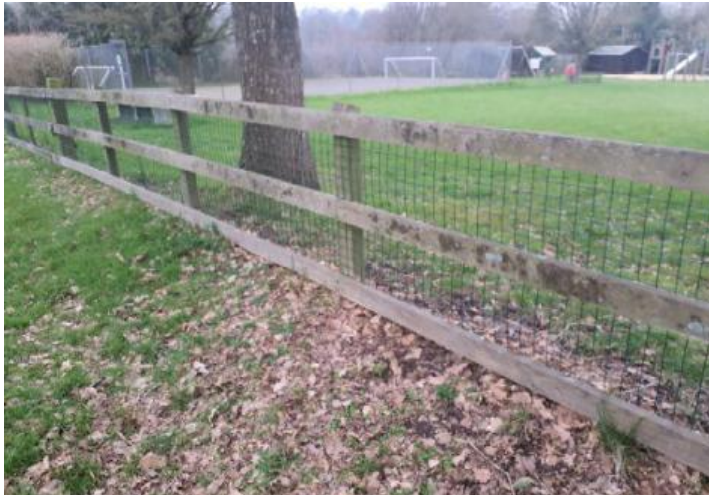
**Item:** Fences - Fence - Timber & Mesh Infill  
**Manufacturer:** Not Identified

**Finding:** There are areas or parts of the timber on the structure that have rotted

**Action:** Replace all affected timbers

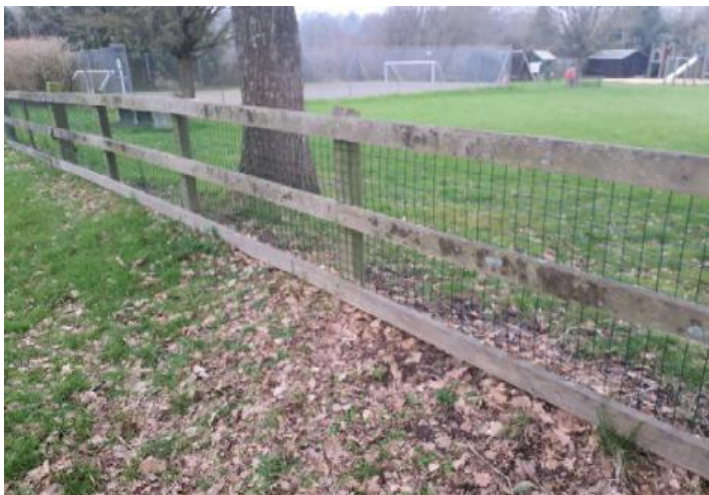
**Item:** Fences - Fence - Timber & Mesh Infill  
**Manufacturer:** Not Identified

**Finding:** There are a number of loose posts around the fence

**Action:** Monitor for any further deterioration and reset as required

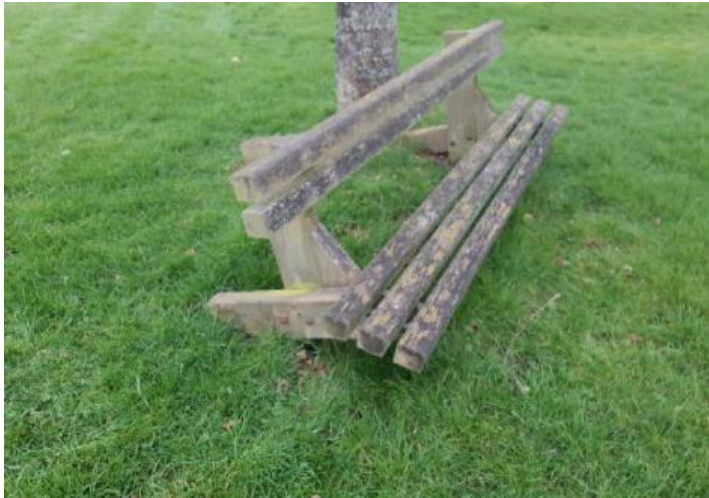
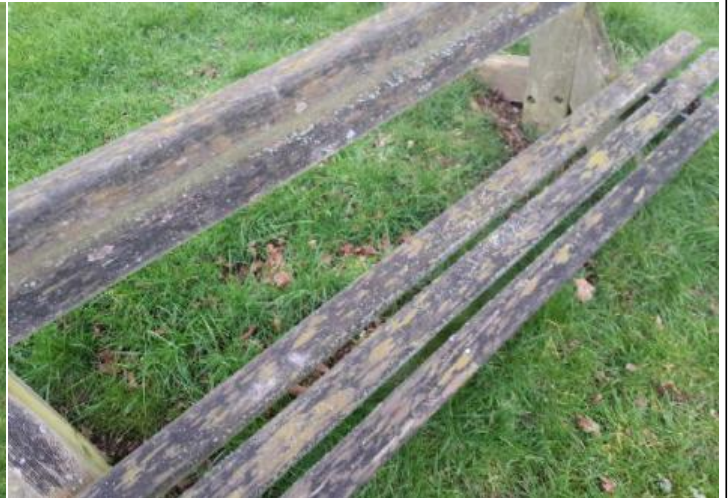
**Item:** Ancillary Items - Bench  
**Manufacturer:** Not Identified

**Finding:** There is algae or moss on the surface of the equipment

**Action:** Clean and treat appropriately

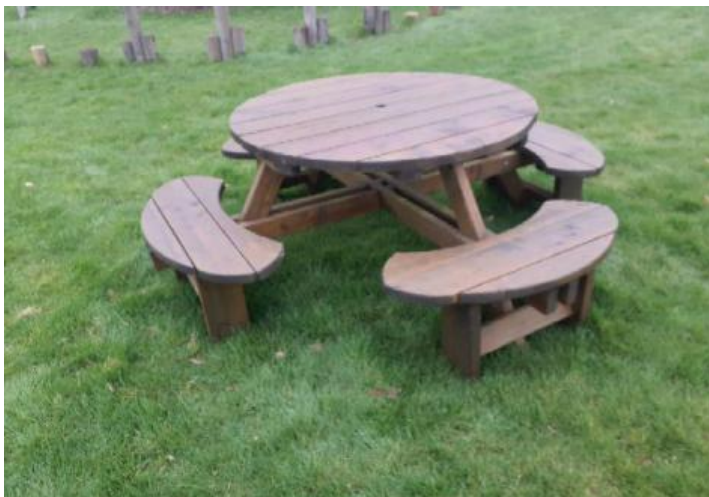
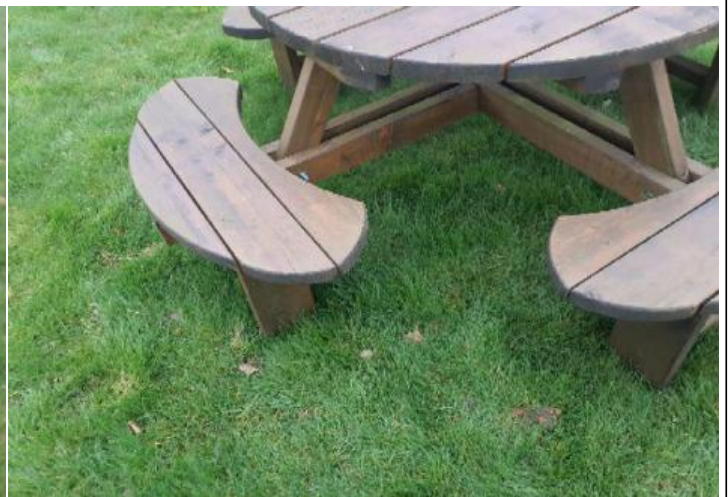
**Item:** Ancillary Items - Picnic Table  
**Manufacturer:** Not Identified

**Finding:** The table/s is/are not secured to the ground and there is some potential for the item/s to be moved within falling spaces of equipment

**Action:** Secure to the ground

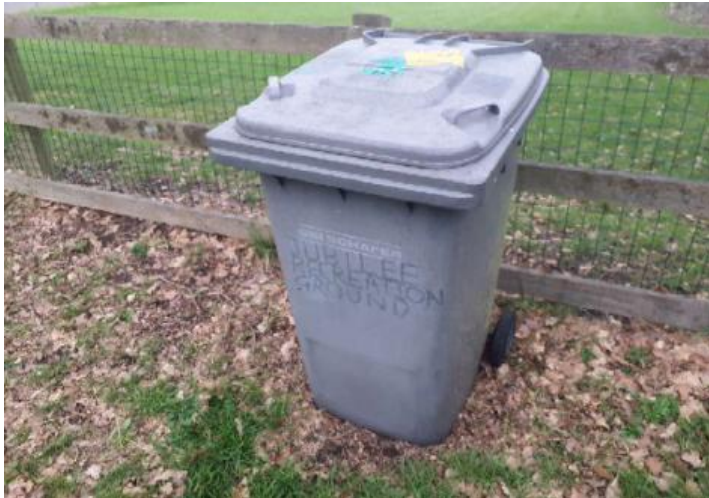
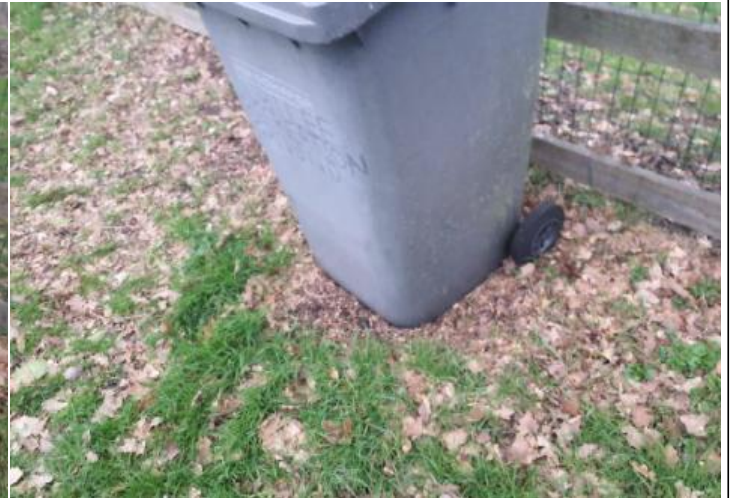
**Item:** Ancillary Items - Litter Bin  
**Manufacturer:** Not Identified

**Finding:** The bin is not securely fixed to the surface and there is some possibility of the item tipping or rolling over

**Action:** Secure the bin to the ground

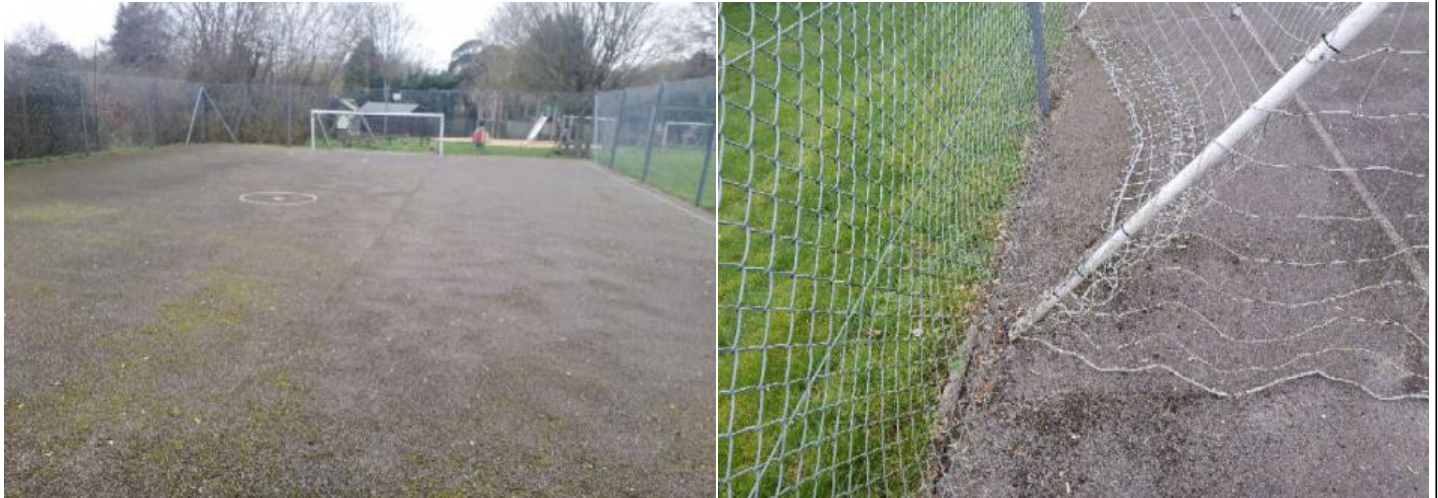
**Item:** Multi Use Games Area - Ball Games Area **Risk Level:** L - Low Risk  
**Manufacturer:** Not Identified **Surface:** Bitmac

**Finding:** The goals nets are not anchored in position **Action:** Secure

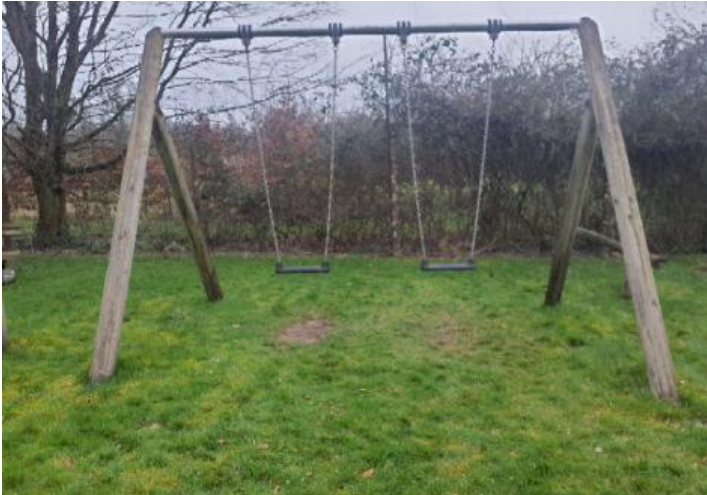
**Item:** Swings - 1 Bay 2 Seat (Flat)  
**Manufacturer:** Playdale Playgrounds Ltd

**Finding:** There are areas or parts of the timber on the structure that have rotted

**Action:** Replace all affected timbers

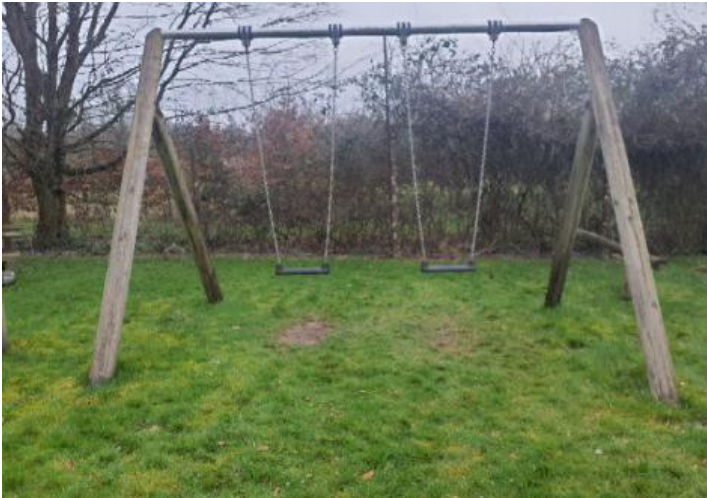
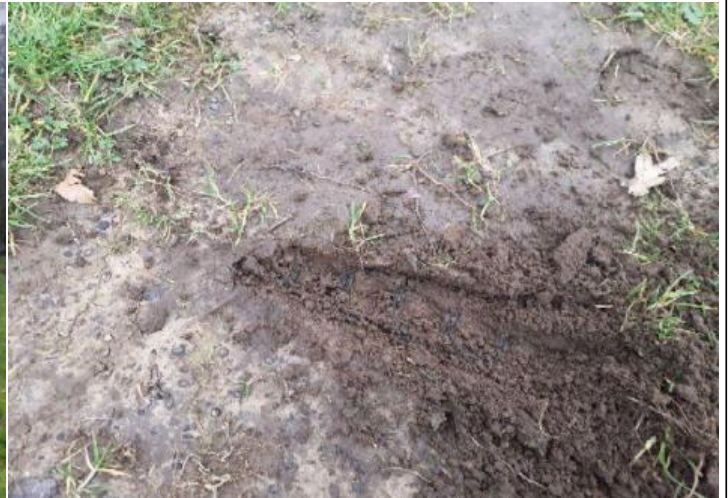
**Item:** Swings - 1 Bay 2 Seat (Flat)  
**Manufacturer:** Playdale Playgrounds Ltd

**Finding:** The grass mats are silted up and the soil is compacted; this may have an effect on the impact absorbing properties of the surface. Consideration should be given to HIC testing the surface to verify impact attenuating properties ( <https://playinspections.co.uk/inspection-services/safety-surface-testing/> )

**Action:** Contact our office for a quotation for this service

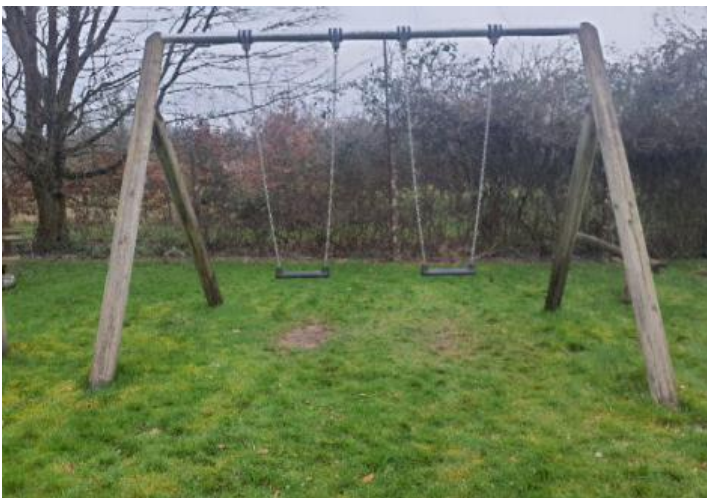
**Item:** Swings - 1 Bay 2 Seat (Flat)  
**Manufacturer:** Playdale Playgrounds Ltd

**Finding:** The seat has minor damage or wear

**Action:** Monitor for any further deterioration and replace as required

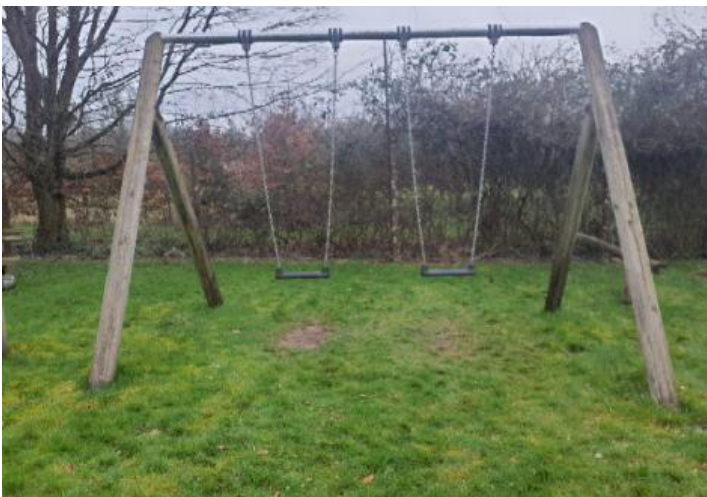
**Finding:** The timber has a number of splits/shakes or air cracks and this may affect the stability or allow water ingress which will accelerate the rotting process

**Action:** Monitor to ensure the splits do not cross through fixing points of the structure and/or cause any instability

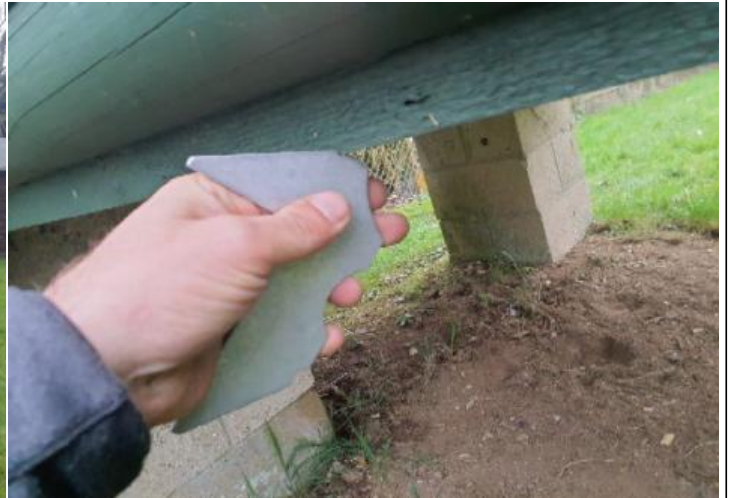
**Finding:** The item has exposed edges and corners that are sharp, or with a radius of less than 3mm, and does not meet the requirements of BS EN 1176 Part 1 - 4.2.5  
**Action:** Provide a 3mm radius to all exposed edges and corners, or remove sharp edge

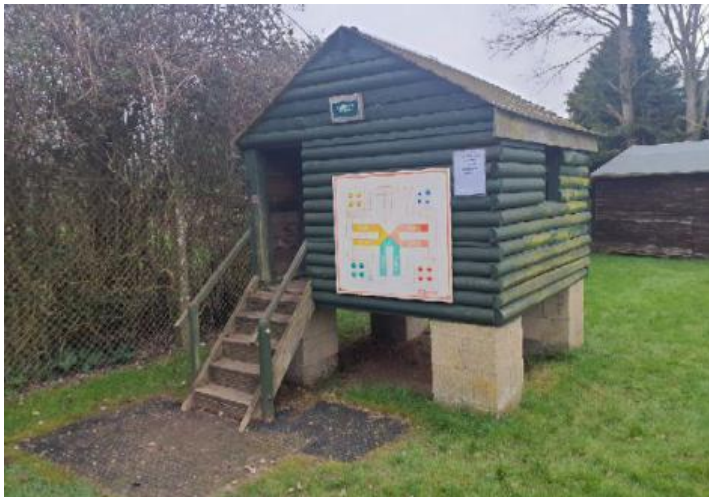
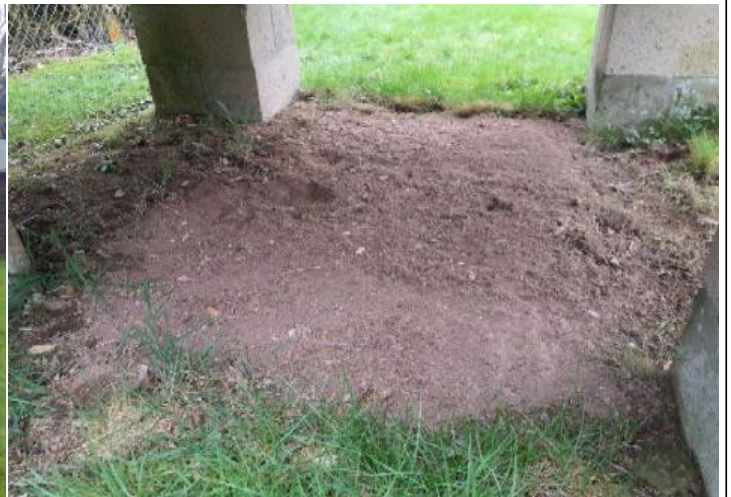
**Finding:** The area around the item has eroded and may become slippery  
**Action:** Reinstate eroded area

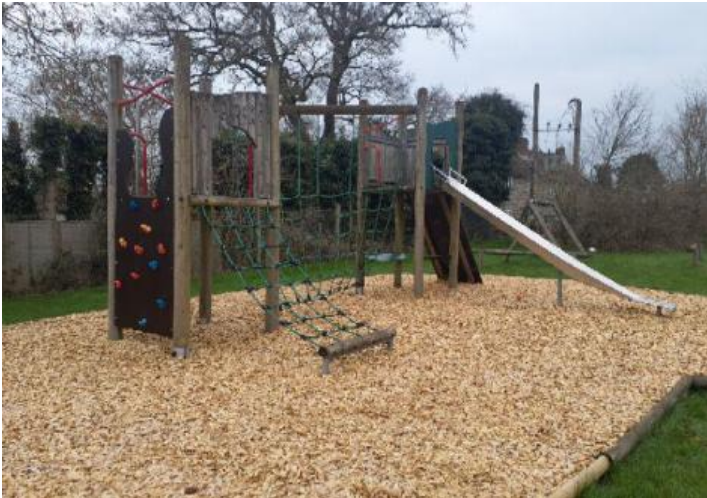
**Finding:** There are areas or parts of the timber on the structure that have rotted

**Action:** Replace all affected timbers

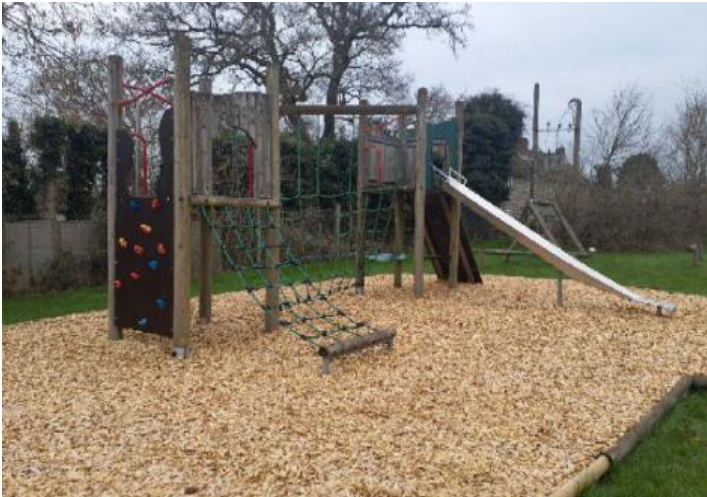
**Finding:** There is/are bolt cap covers missing or damaged on the item

**Action:** Replace missing or damaged bolt cap covers

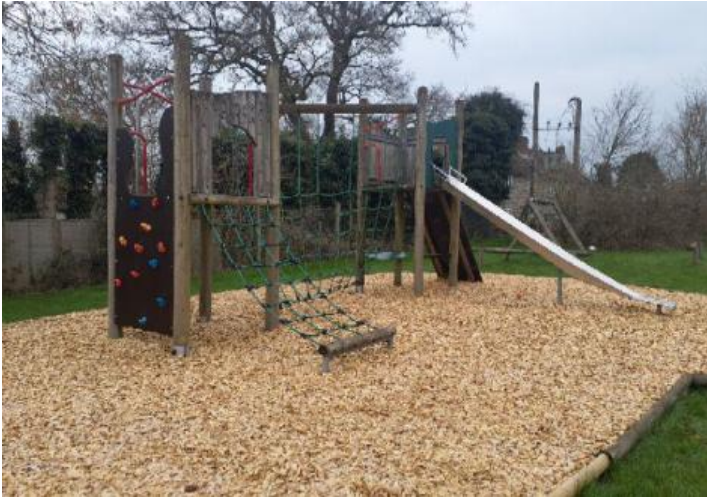
**Finding:** There are areas or parts of the timber on the structure that have rotted (client notified)

**Action:** Replace all affected timbers

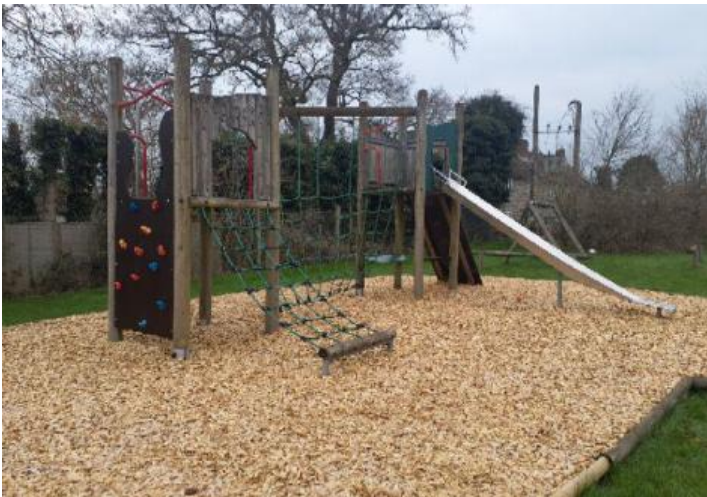
**Finding:** The inspector has some concerns about the internal condition of the timber and was unable to verify the structural integrity without further testing. We recommend a Resi-PD survey to establish the condition of the timber at it's core.

**Action:** Contact the Play Inspection Company office for further information

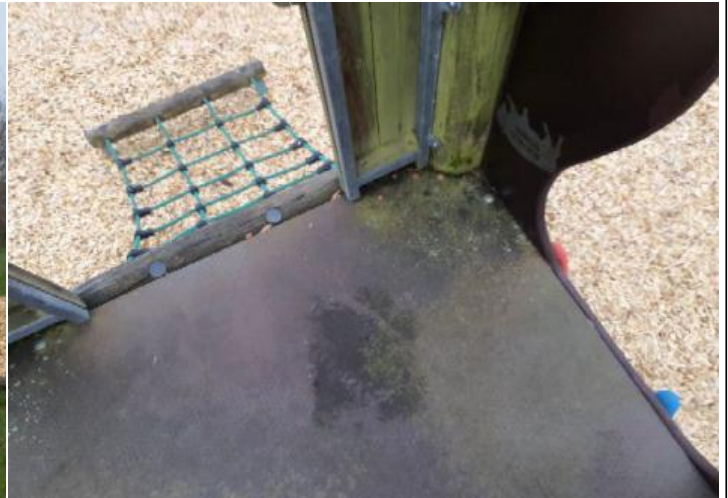
**Finding:** There is algae or moss on the surface of the equipment

**Action:** Clean and treat appropriately

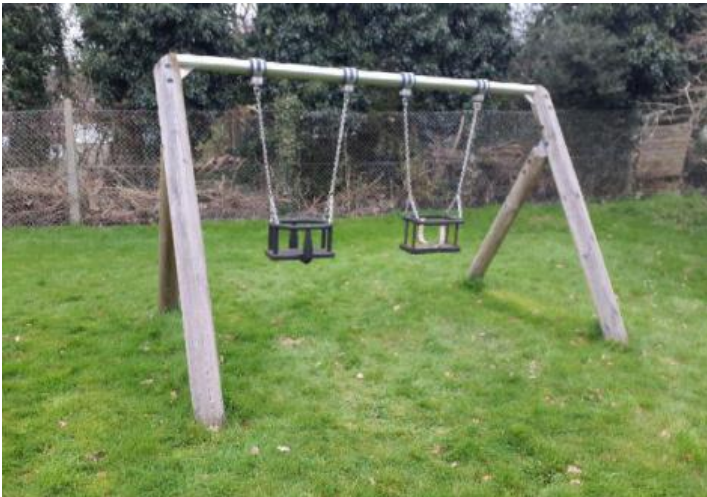
**Finding:** There is some evidence of rot in the timber

**Action:** Monitor for any further deterioration and replace as required

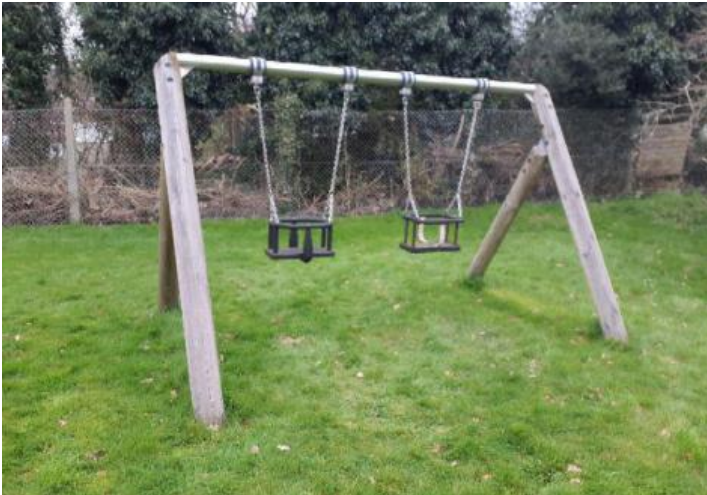
**Finding:** There is some notable evidence of chain wear

**Action:** Monitor for any further deterioration and replace when 40% worn

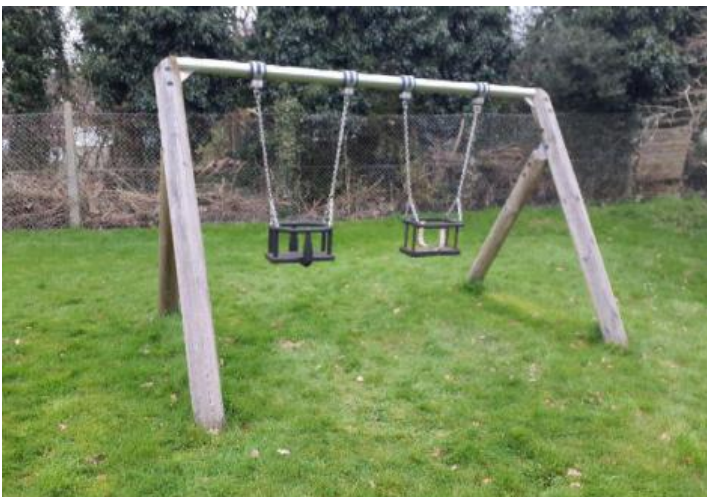
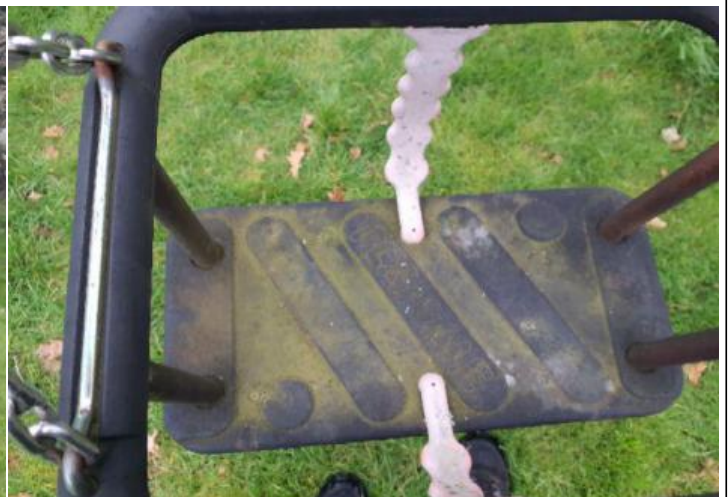
**Finding:** There is algae or moss on the surface of the equipment

**Action:** Clean and treat appropriately

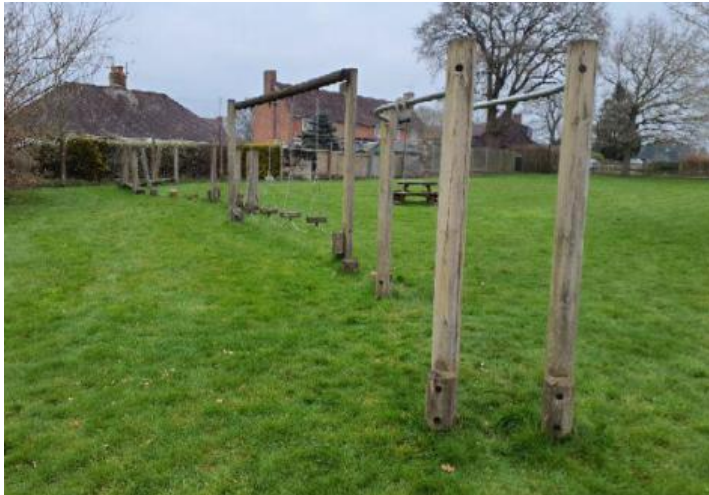
**Finding:** A number of fixing(s) have worked loose

**Action:** Secure all loose fixings

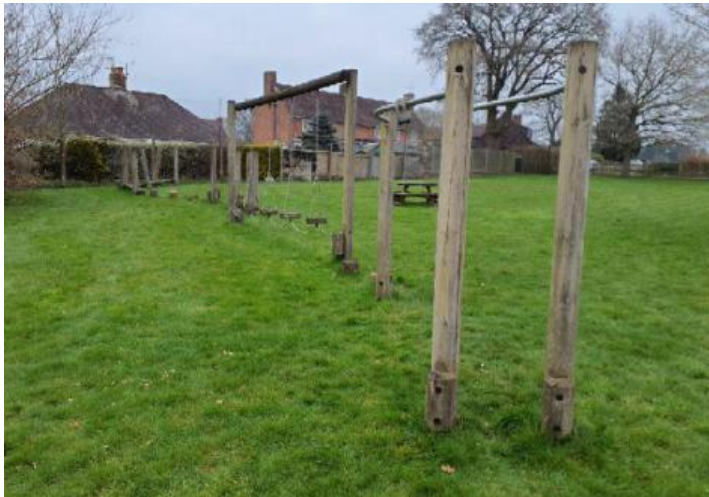
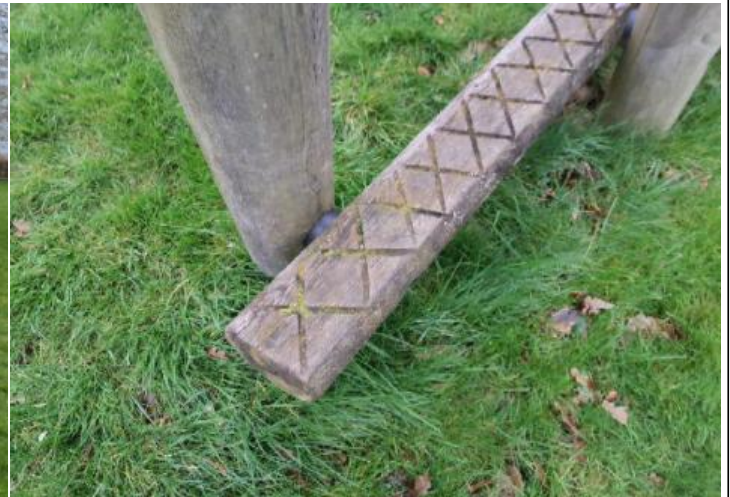
**Finding:** There is algae or moss on the surface of the equipment

**Action:** Clean and treat appropriately

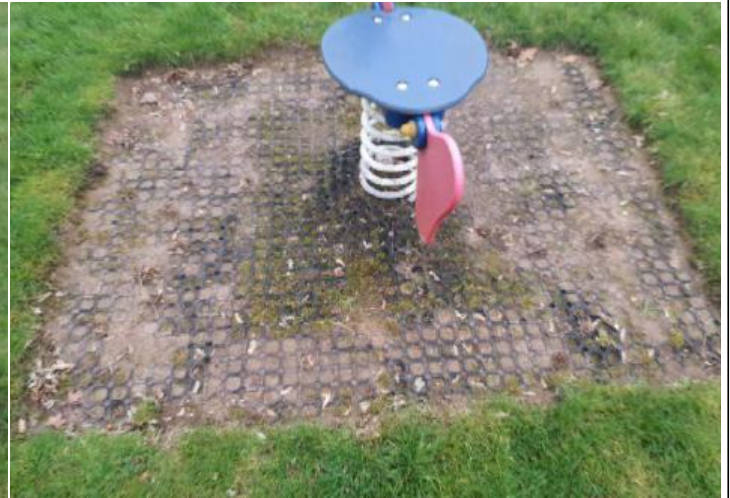
**Finding:** The grass mats are silted up, the soil is compacted and the area will become very slippery when the soil is wet. **Action:** Reinstate as required
